## Trimble NetRS - tracking behavior changes after firmware upgrade

698 Henry Berglund March 10, 2011 [GNSS Receiver Test Reports](#), [Trimble NetRS](#) 590

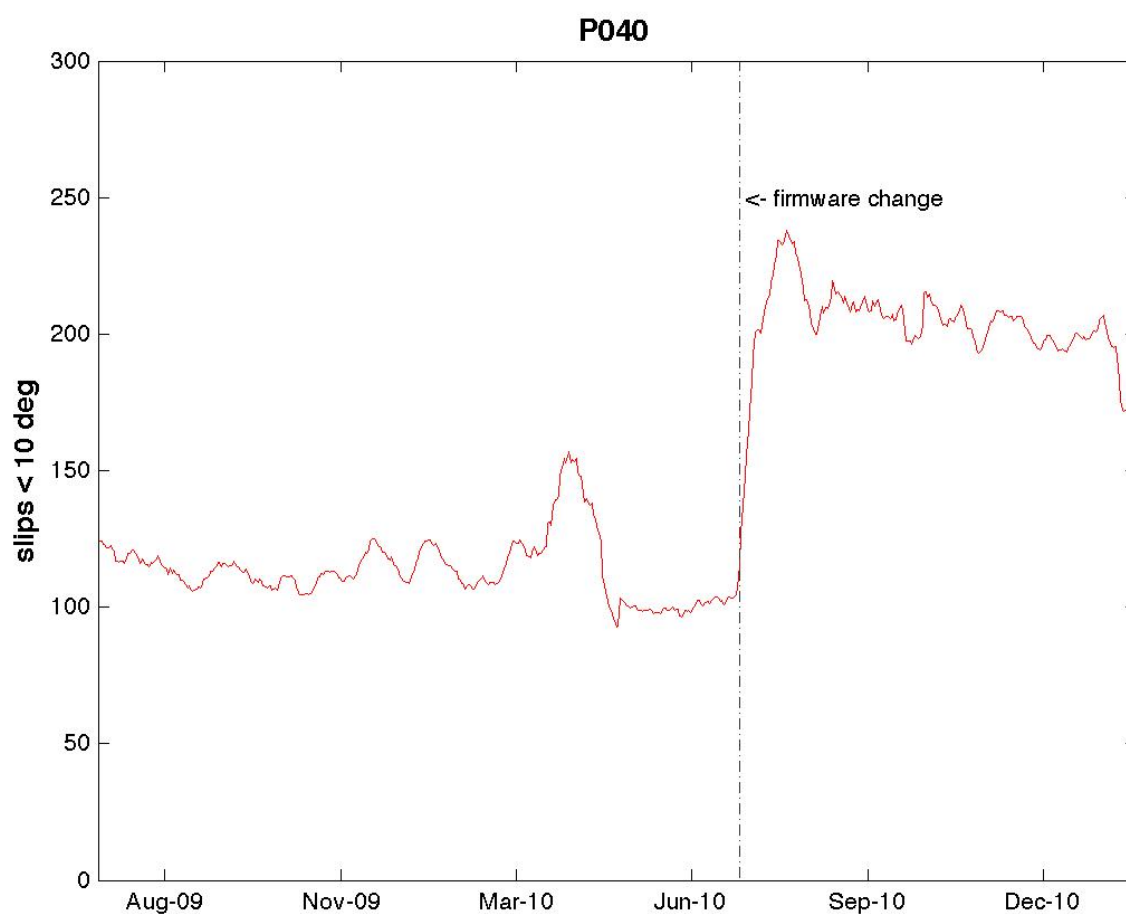
The following figure shows 24-hour totals of MP or IOD slips that occur at the site P040 when the elevation angles were < 10 degrees. The gray dashed line indicates when the receiver firmware at P040 was upgraded from 1.1-2 to 1.3-0. The average number of IOD or MP slips before the firmware change is 113. The average IOD or MP slips after the firmware change is 205.

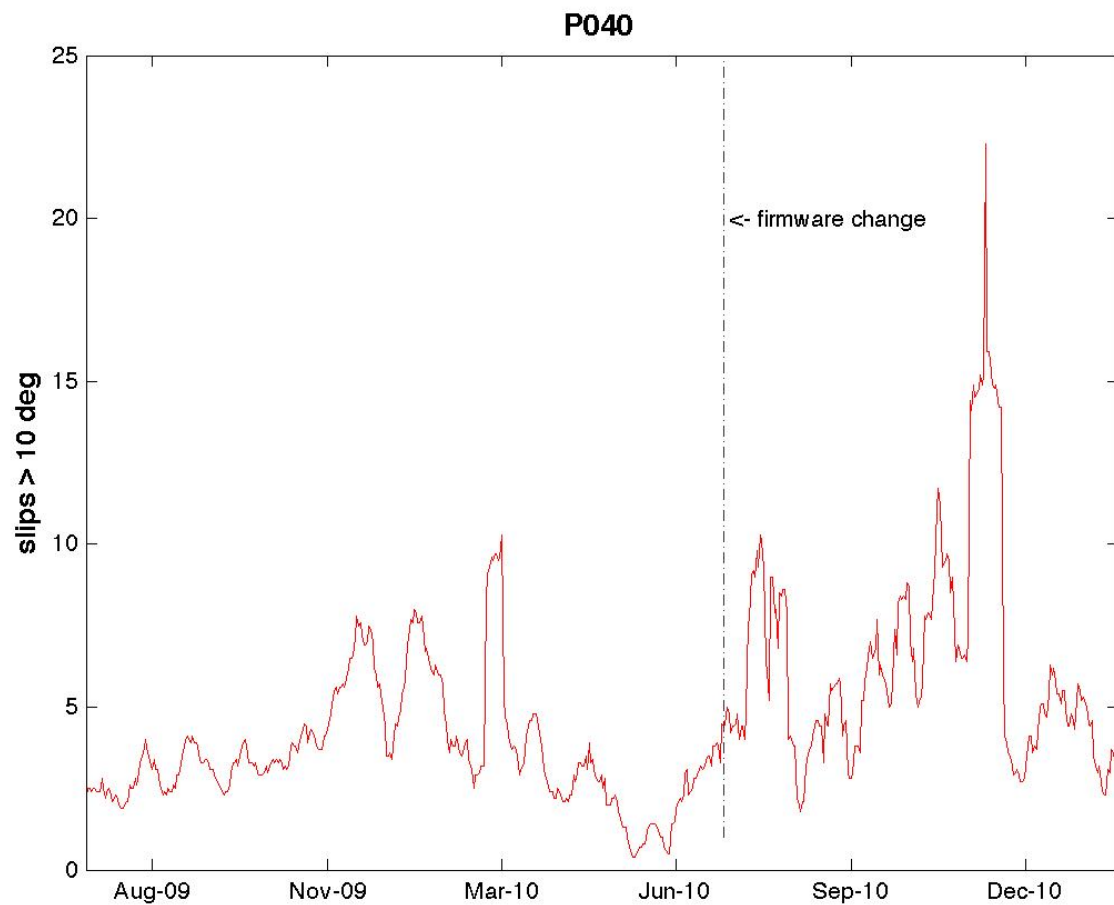
The following figure shows 24-hour totals of MP or IOD slips that occur at the site P040 when the

elevation angles were  $> 10$  degrees. The average number of IOD or MP slips before the firmware change is 3.67. The average IOD or MP slips after the firmware change is 6.33.

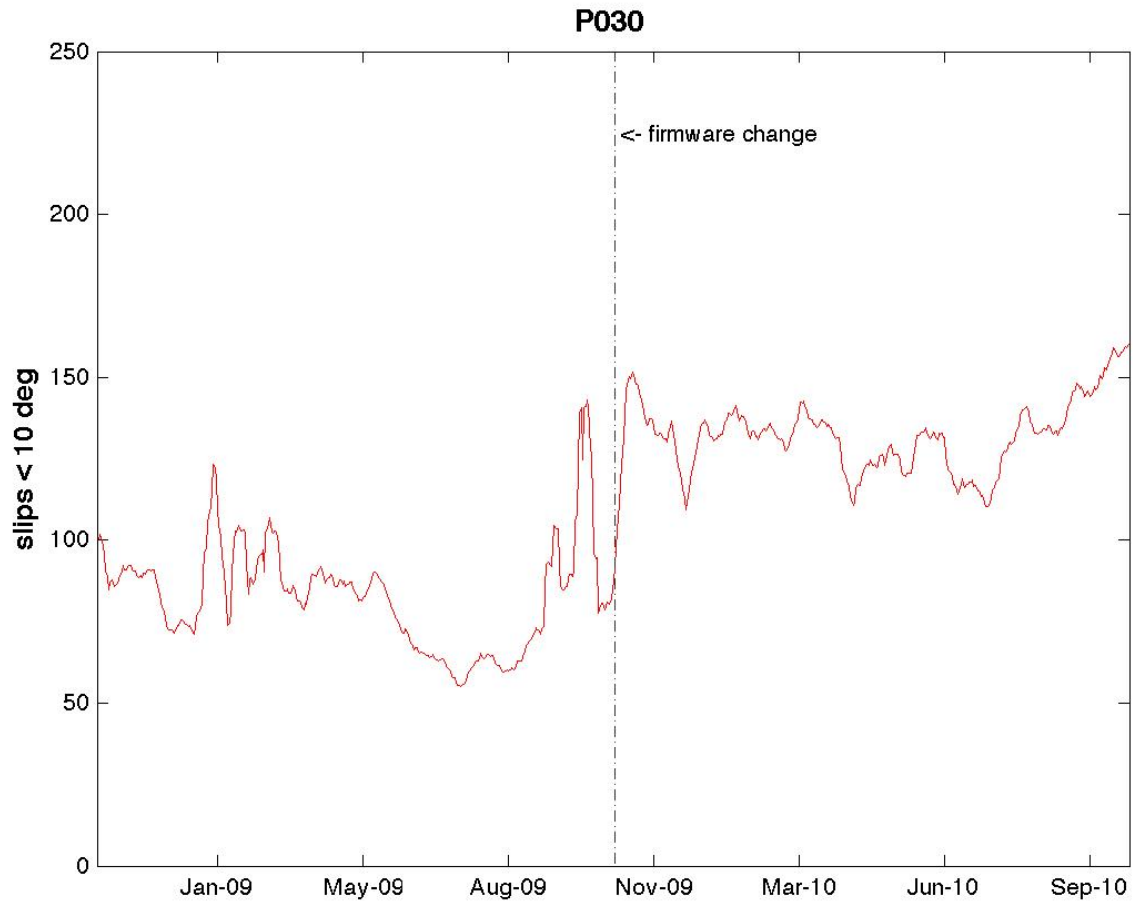
The following figure shows 24-hour totals of MP or IOD slips that occur at the site P030 when the elevation angles were  $< 10$  degrees. The gray dashed line indicates when the receiver firmware at P030 was upgraded from 1.1-2 to 1.3-0. The average number of IOD or MP slips before the firmware change is 83. The average IOD or MP slips after the firmware change is 133.

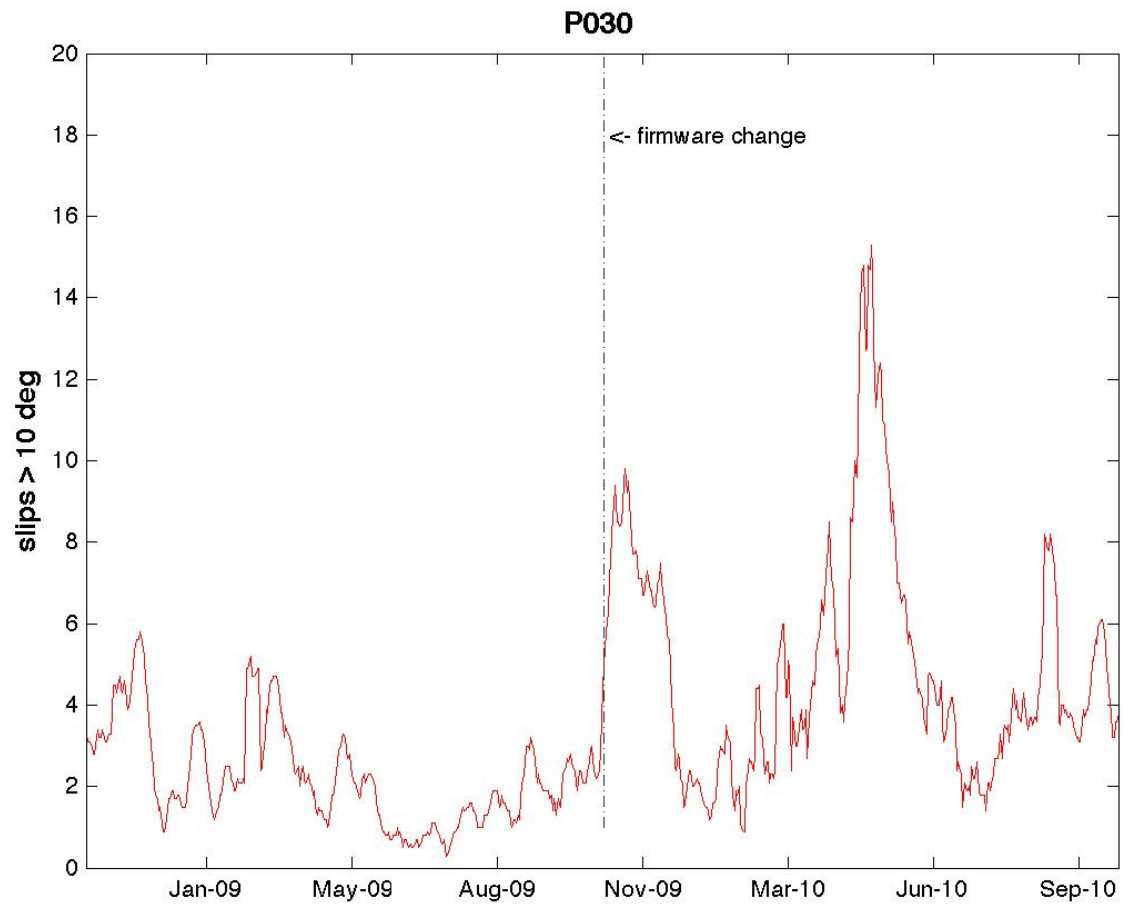
The following figure shows 24-hour totals of MP or IOD slips that occur at the site P030 when the elevation angles were  $> 10$  degrees. The average number of IOD or MP slips before the firmware change is 2.34. The average IOD or MP slips after the firmware change is 4.90.

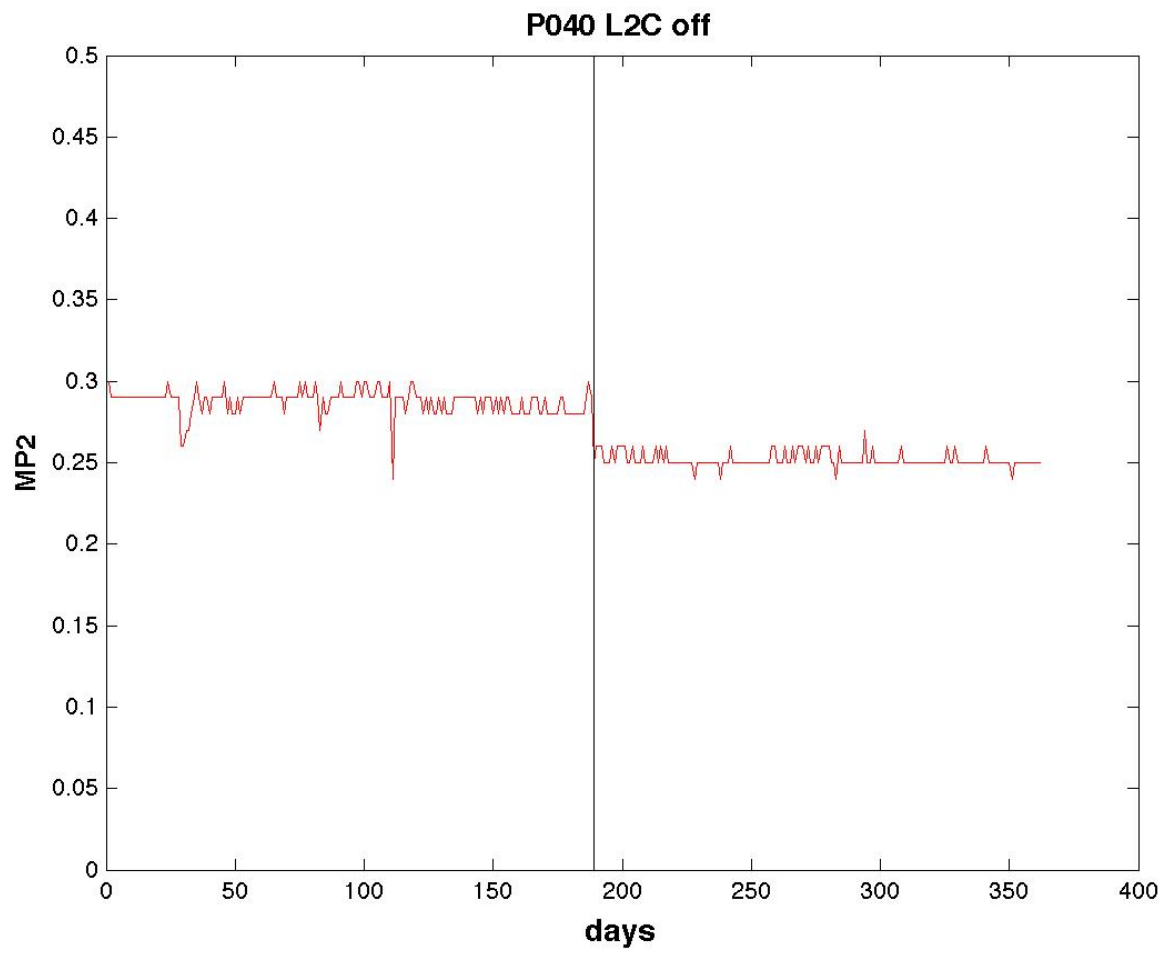
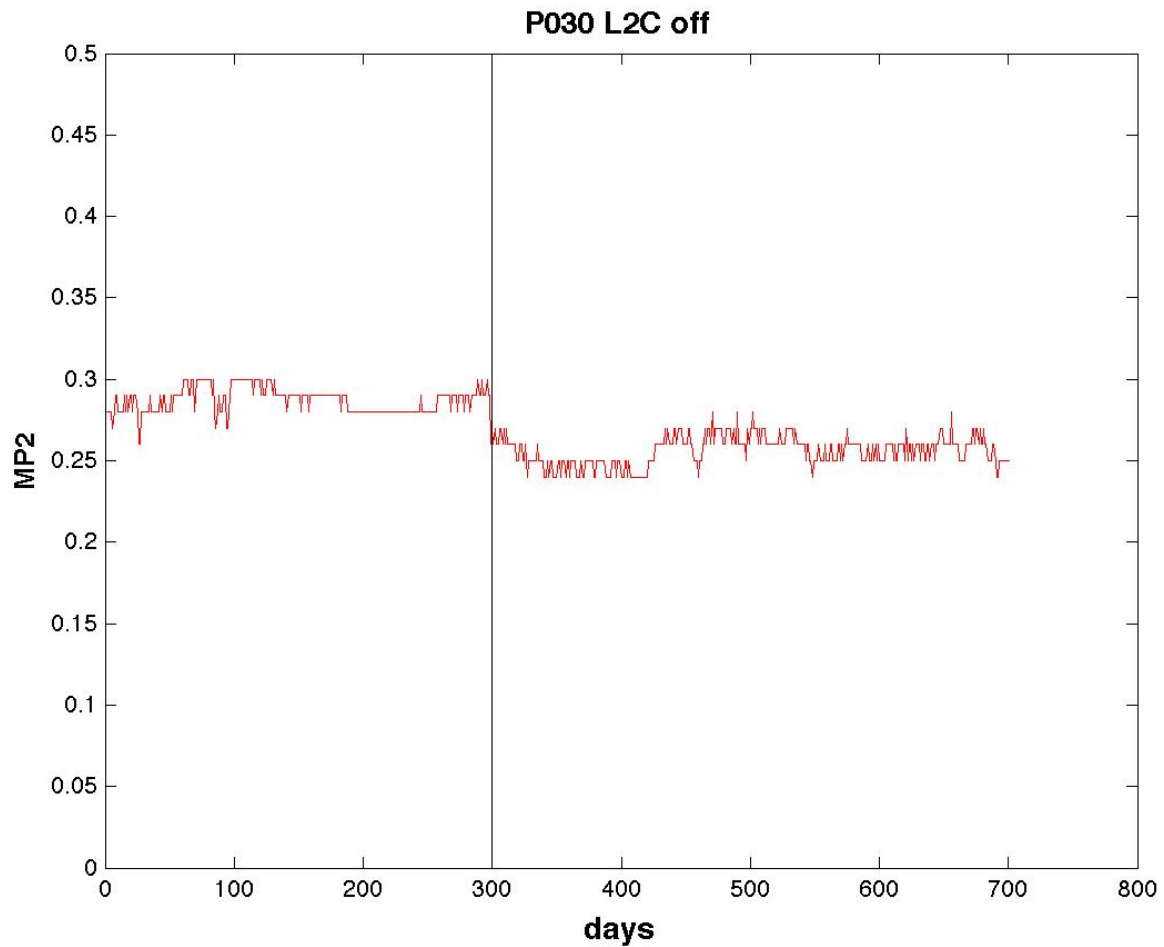
We also observed decreases in MP2 values after the firmware was updated at the sites P040 and P030. The figures below shows the MP2 values calculated by Teqc with respect to time.
