Trimble NetRS - tracking behavior changes after firmware upgrade

Article Number: 698 | Rating: Unrated | Last Updated: Thu, Mar 10, 2011 at 11:41 PM

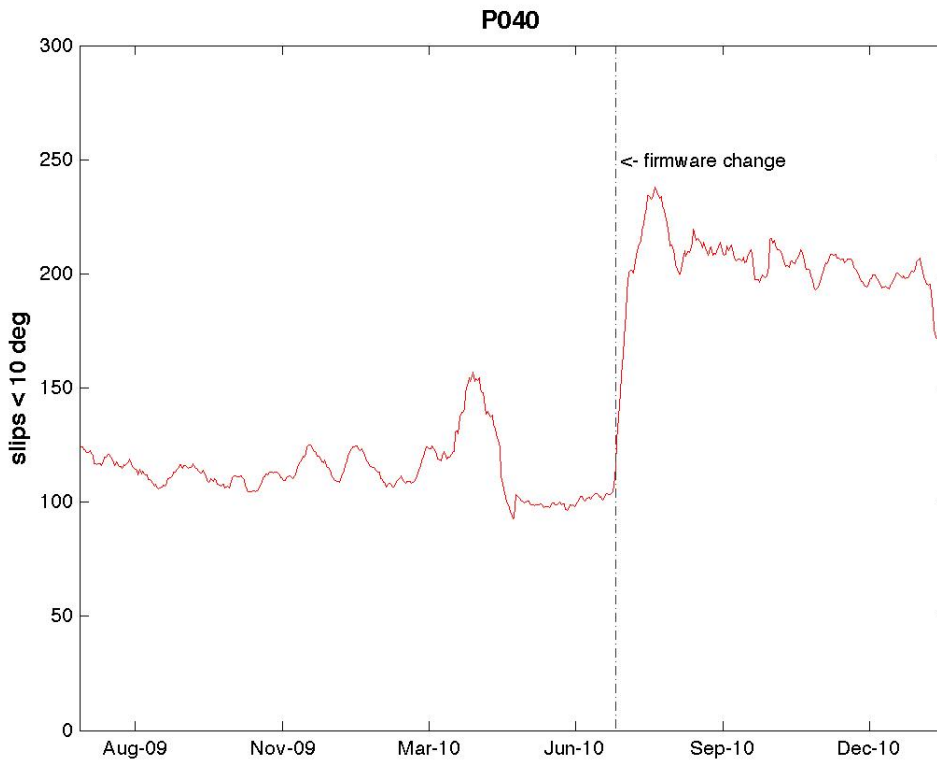
The following figure shows 24-hour totals of MP or IOD slips that occur at the site P040 when the elevation angles were < 10 degrees. The gray dashed line indicates when the receiver firmware at P040 was upgraded from 1.1-2 to 1.3-0. The average number of IOD or MP slips before the firmware change is 113. The average IOD or MP slips after the firmware change is 205.

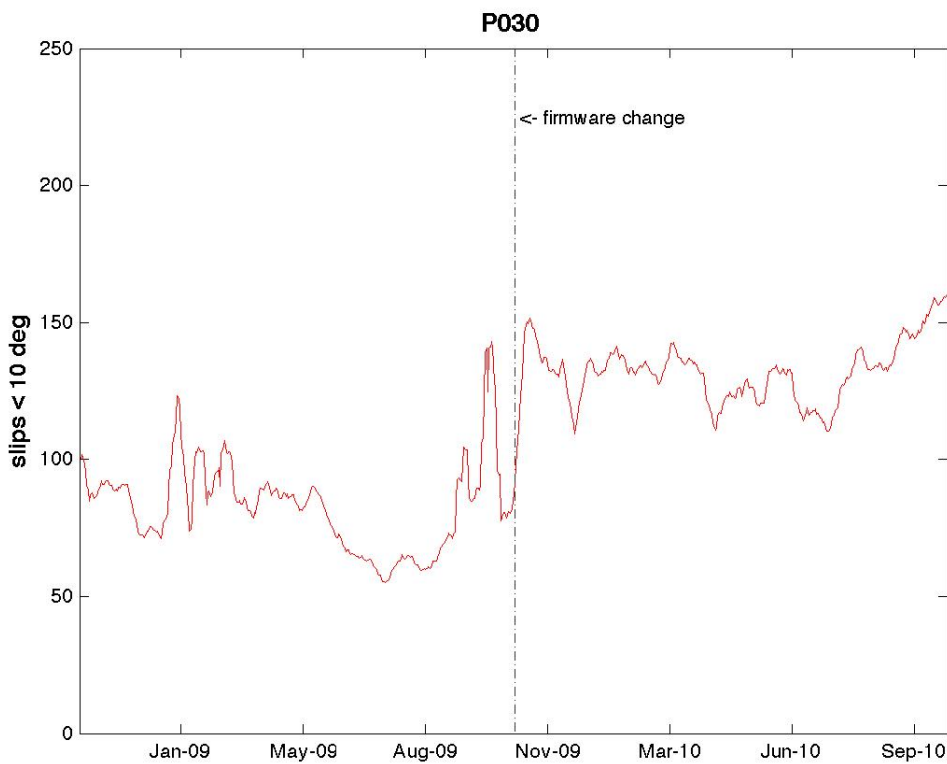
The following figure shows 24-hour totals of MP or IOD slips that occur at the site P030 when the elevation angles were < 10 degrees. The gray dashed line indicates when the receiver firmware at P030 was upgraded from 1.1-2 to 1.3-0. The average number of IOD or MP slips before the firmware change is 83. The average IOD or MP slips after the firmware change is 133.

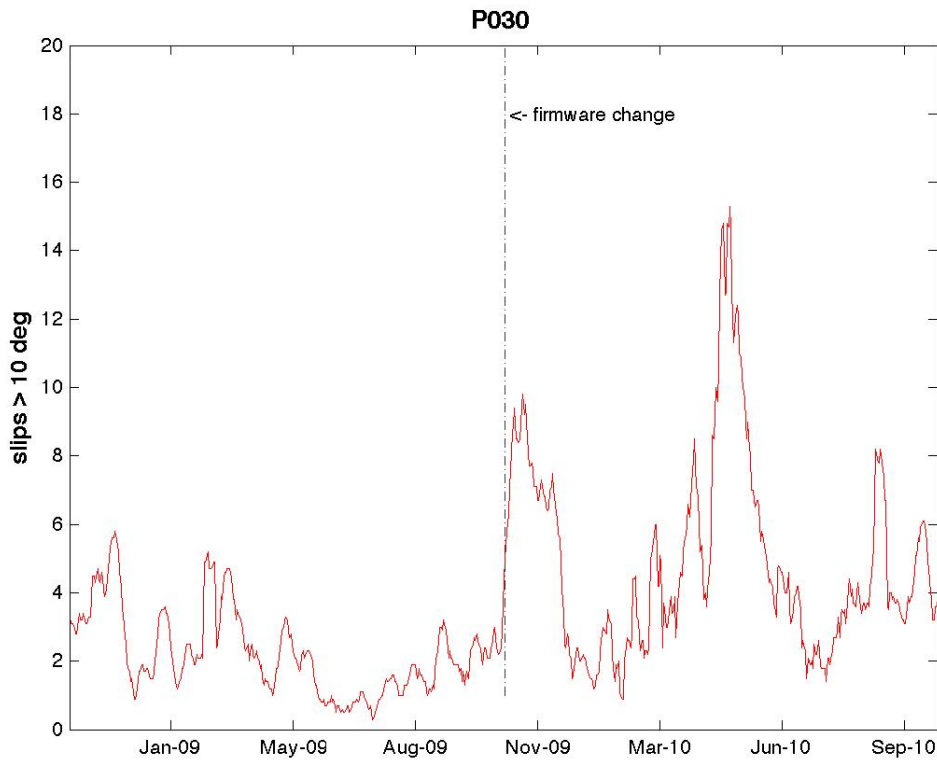
The following figure shows 24-hour totals of MP or IOD slips that occur at the site P030 when the elevation angles were > 10 degrees. The average number of IOD or MP slips before the firmware change is 2.34. The average IOD or MP slips after the firmware change is 4.90.

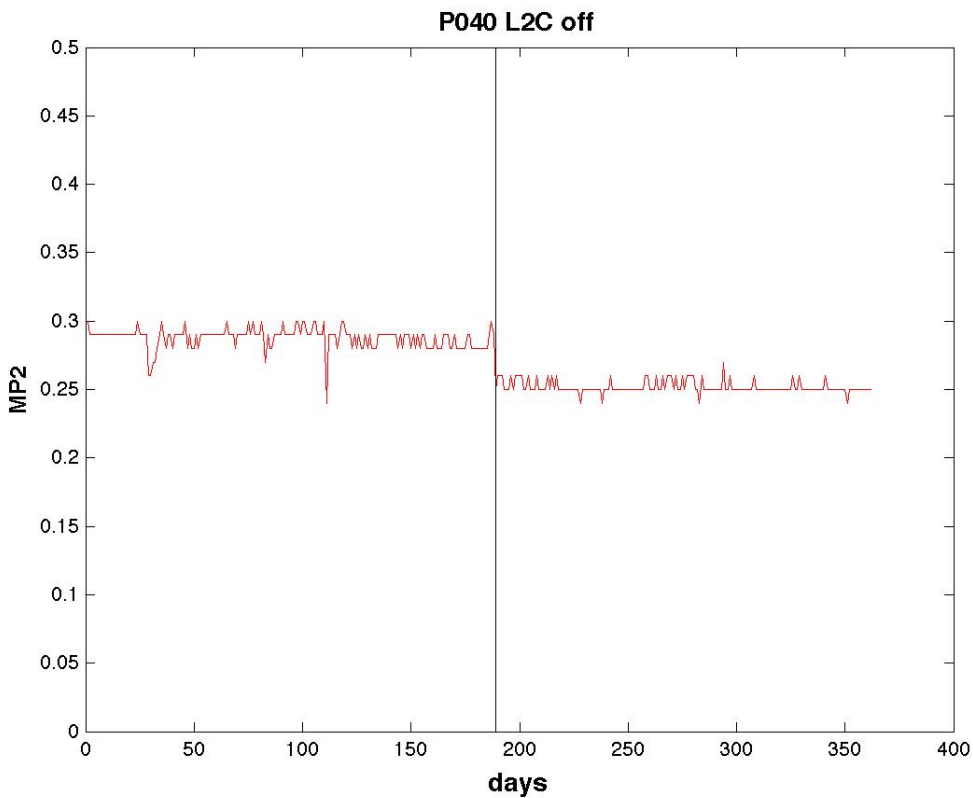
We also observed decreases in MP2 values after the firmware was updated at the sites P040 and P030. The figures below shows the MP2 values calculated by Teqc with respect to time.
