Trimble NetRS - tracking behavior changes after firmware upgrade

Article Number: 698 | Rating: Unrated | Last Updated: Thu, Mar 10, 2011 at 11:41 PM

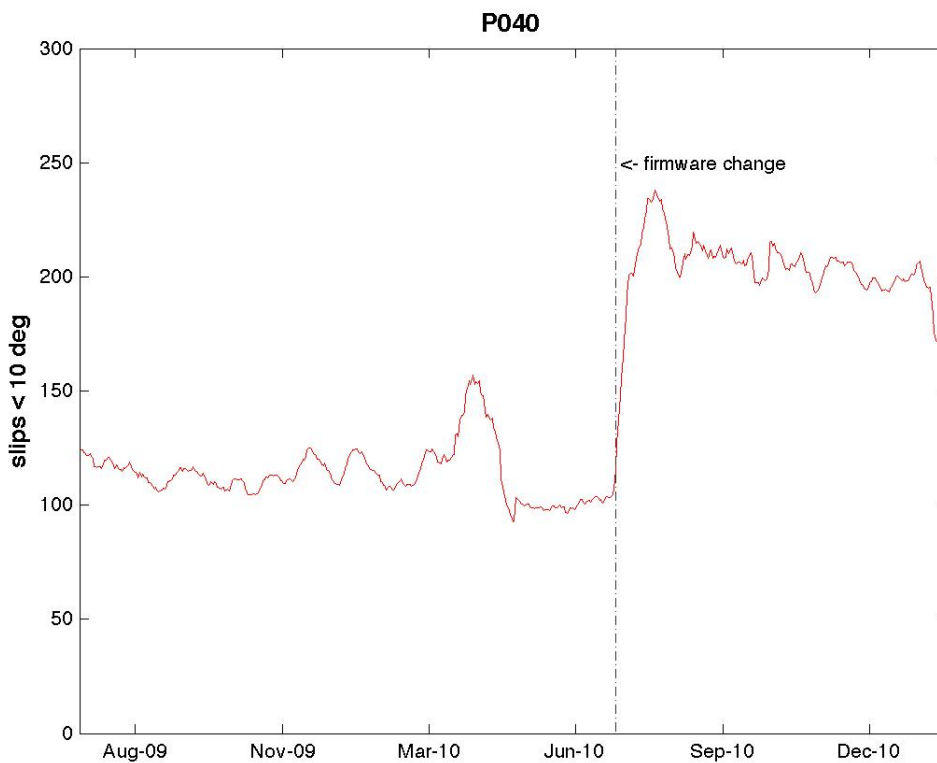
The following figure shows 24-hour totals of MP or IOD slips that occur at the site P040 when the elevation angles were < 10 degrees. The gray dashed line indicates when the receiver firmware at P040 was upgraded from 1.1-2 to 1.3-0. The average number of IOD or MP slips before the firmware change is 113. The average IOD or MP slips after the firmware change is 205.

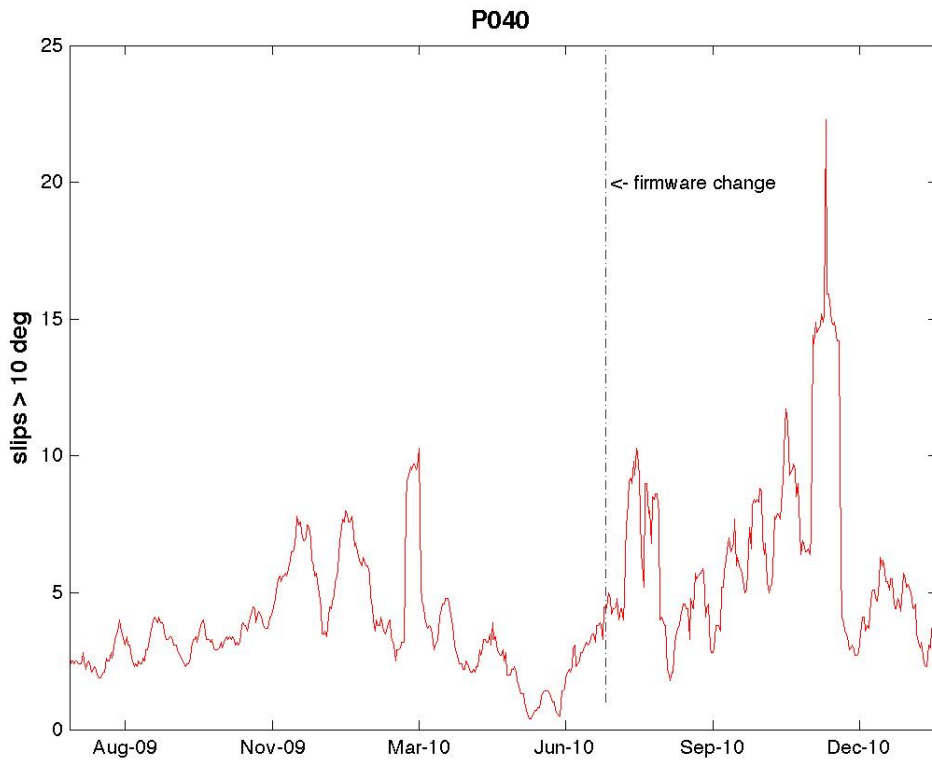
The following figure shows 24-hour totals of MP or IOD slips that occur at the site P040 when the elevation angles were > 10 degrees. The average number of IOD or MP slips before the firmware change is 3.67. The average IOD or MP slips after the firmware change is 6.33.

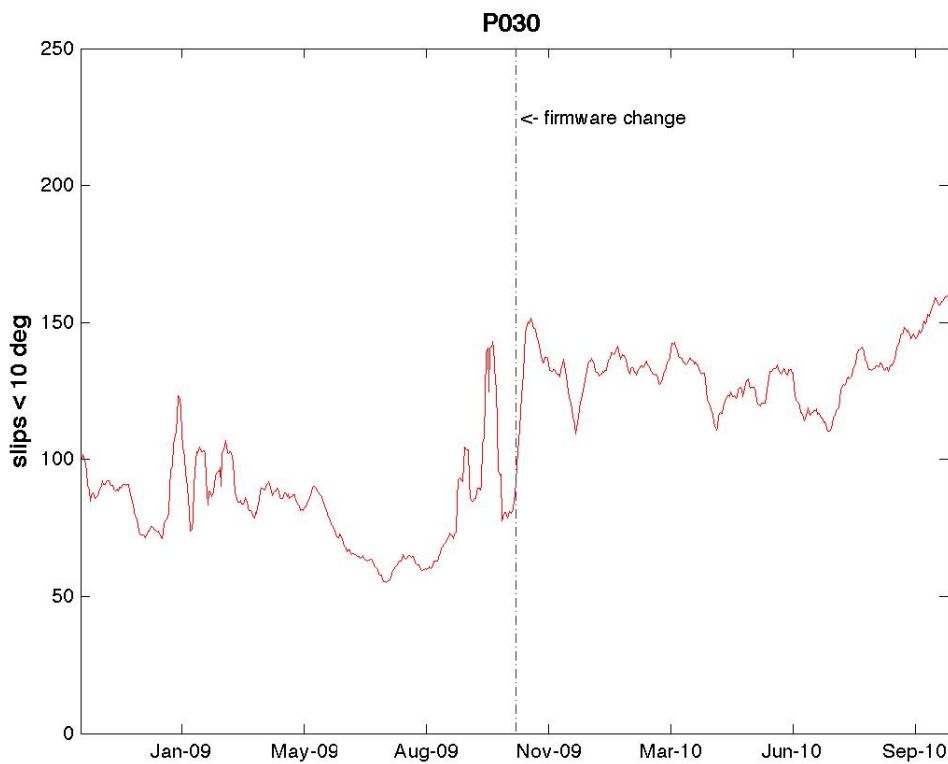
The following figure shows 24-hour totals of MP or IOD slips that occur at the site P030 when the elevation angles were < 10 degrees. The gray dashed line indicates when the receiver firmware at P030 was upgraded from 1.1-2 to 1.3-0. The average number of IOD or MP slips before the firmware change is 83. The average IOD or MP slips after the firmware change is 133.

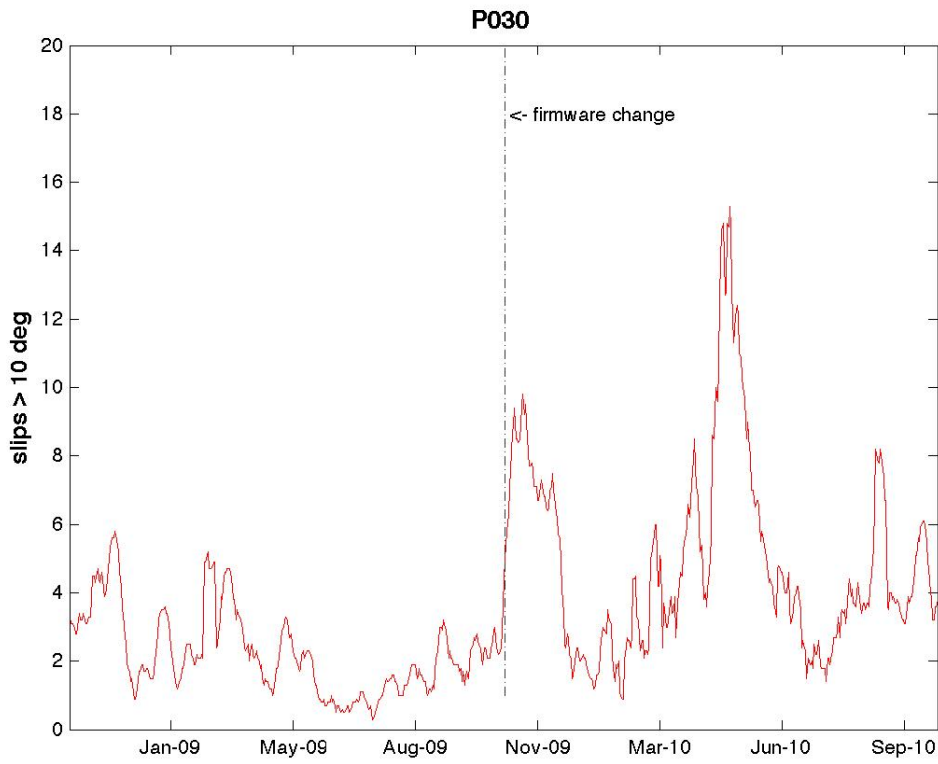
The following figure shows 24-hour totals of MP or IOD slips that occur at the site P030 when the elevation angles were > 10 degrees. The average number of IOD or MP slips before the firmware change is 2.34. The average IOD or MP slips after the firmware change is 4.90.

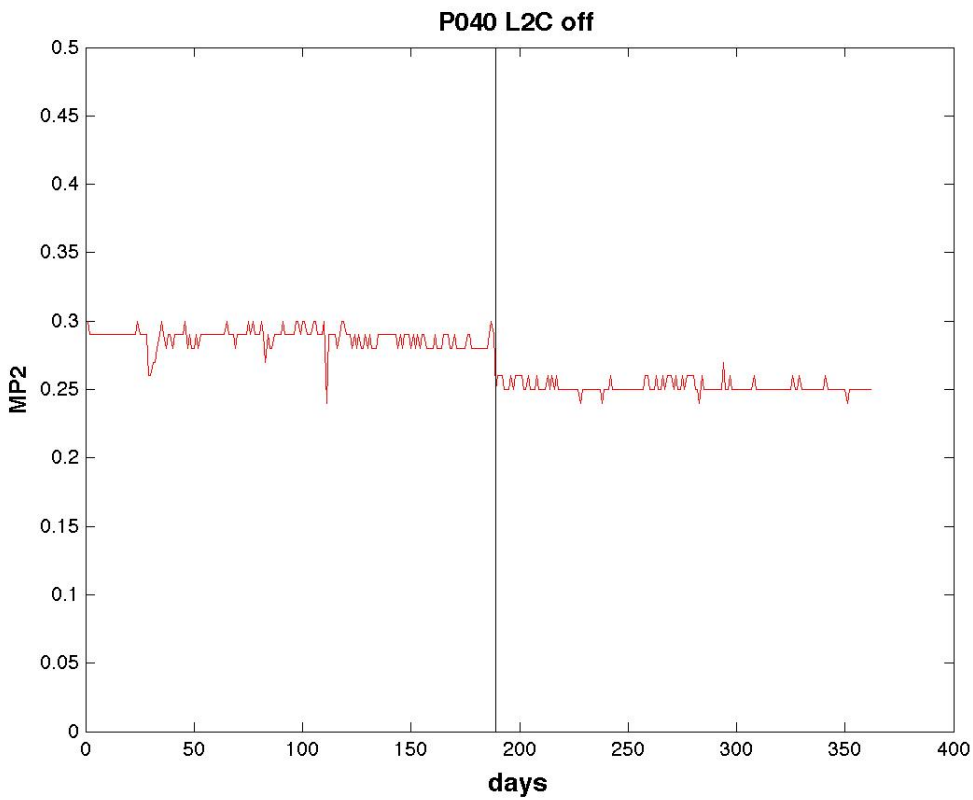
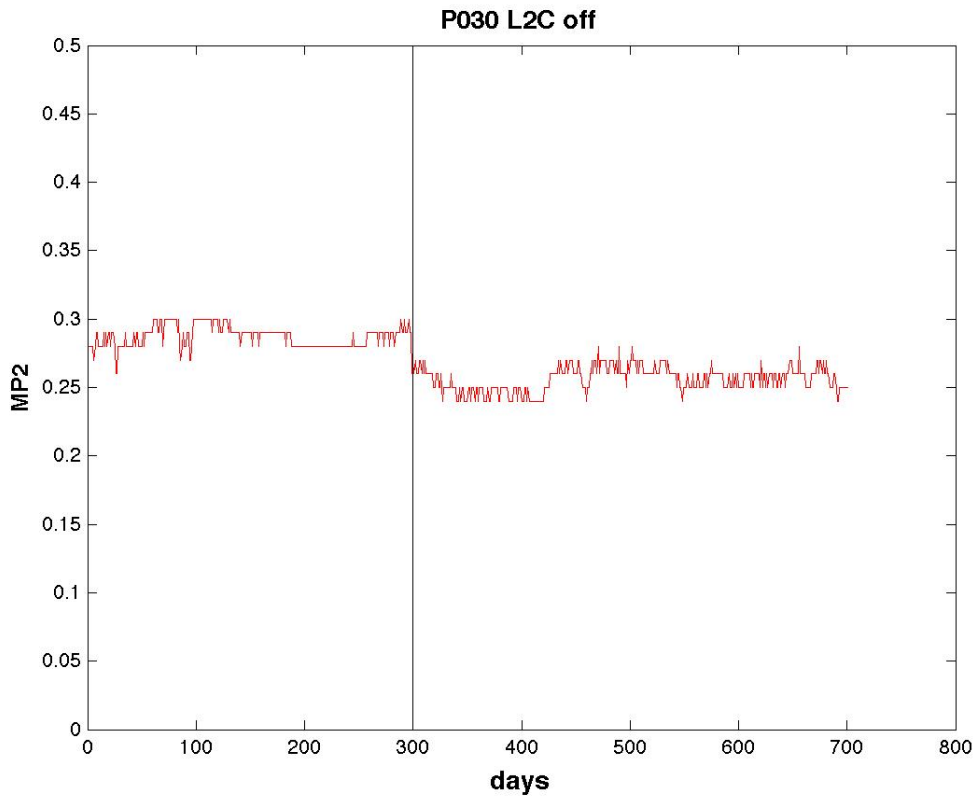
We also observed decreases in MP2 values after the firmware was updated at the sites P040 and P030. The figures below shows the MP2 values calculated by Teqc with respect to time.
