Firmware glitch affects Trimble NetRS Receivers on 31 October, 2010

676 Freddy Blume November 23, 2015 [Trimble NetRS](#) 3064

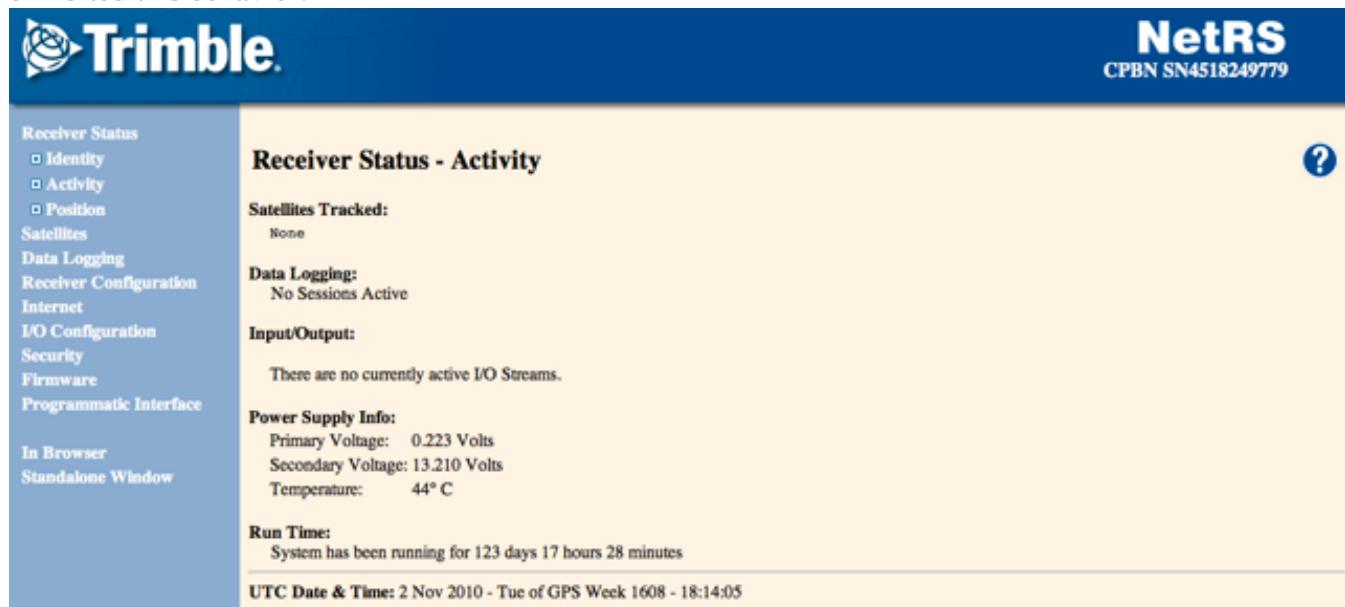
4. System stops tracking SV's and logging data but does not restart:

Error messages appear in the system logs, many processes crash, but a restart is NOT triggered. Receiver is left in a state that its web server is accessible, but is not tracking or logging, and data sessions revert to "Pending" instead of active (see the screen shots below for examples). The active data files at the time continue to show as being active in most cases. Data reports for these receivers will show either 8% or zero for 10/31 and zeros for 11/1 and 11/2. THESE STATIONS REQUIRE REBOOTS either via the web interface or by cycling power to resume normal operation. After the user restarts the receiver the data files from 10/31 have been preserved. About 5% of the UNAVCO-operated NetRS population exhibited this behavior.

If you encounter receivers in this state, go to the "Receiver Configuration -> System Reset" and do a simple restart.
