# Trimble NetRS - tracking behavior changes after firmware upgrade

698 Henry Berglund March 10, 2011 [GNSS Receiver Test Reports, Trimble NetRS](#) 1177

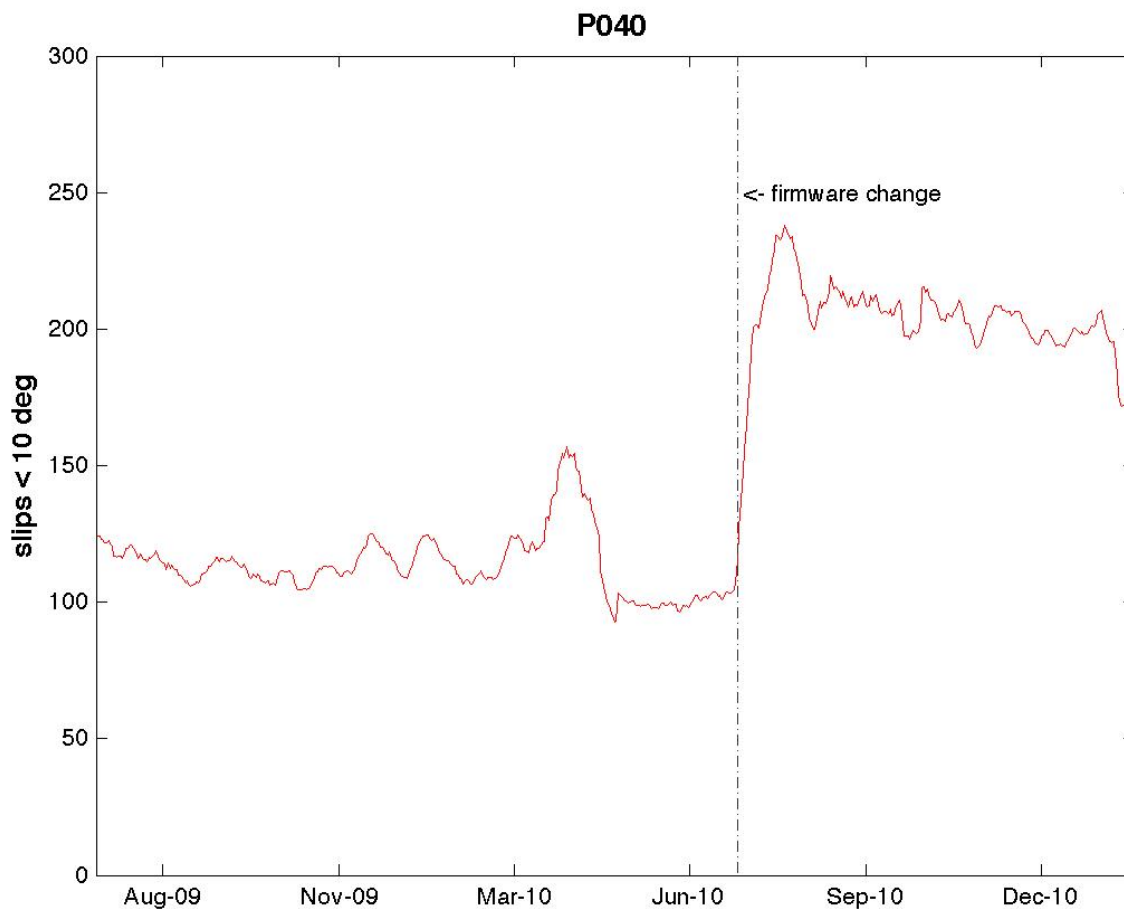
The following figure shows 24-hour totals of MP or IOD slips that occur at the site P040 when the elevation angles were < 10 degrees. The gray dashed line indicates when the receiver firmware at P040 was upgraded from 1.1-2 to 1.3-0. The average number of IOD or MP slips before the firmware change is 113. The average IOD or MP slips after the firmware change is 205.

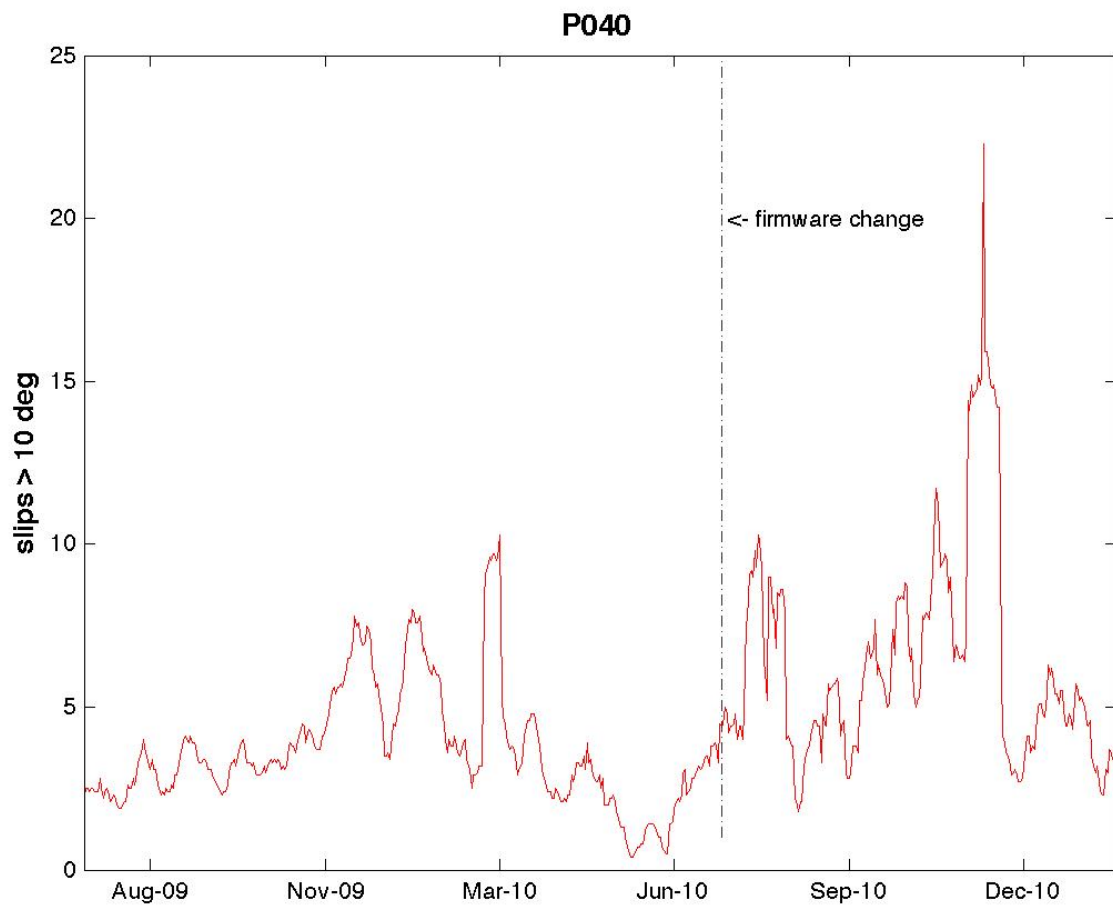
The following figure shows 24-hour totals of MP or IOD slips that occur at the site P040 when the

elevation angles were > 10 degrees. The average number of IOD or MP slips before the firmware change is 3.67. The average IOD or MP slips after the firmware change is 6.33.

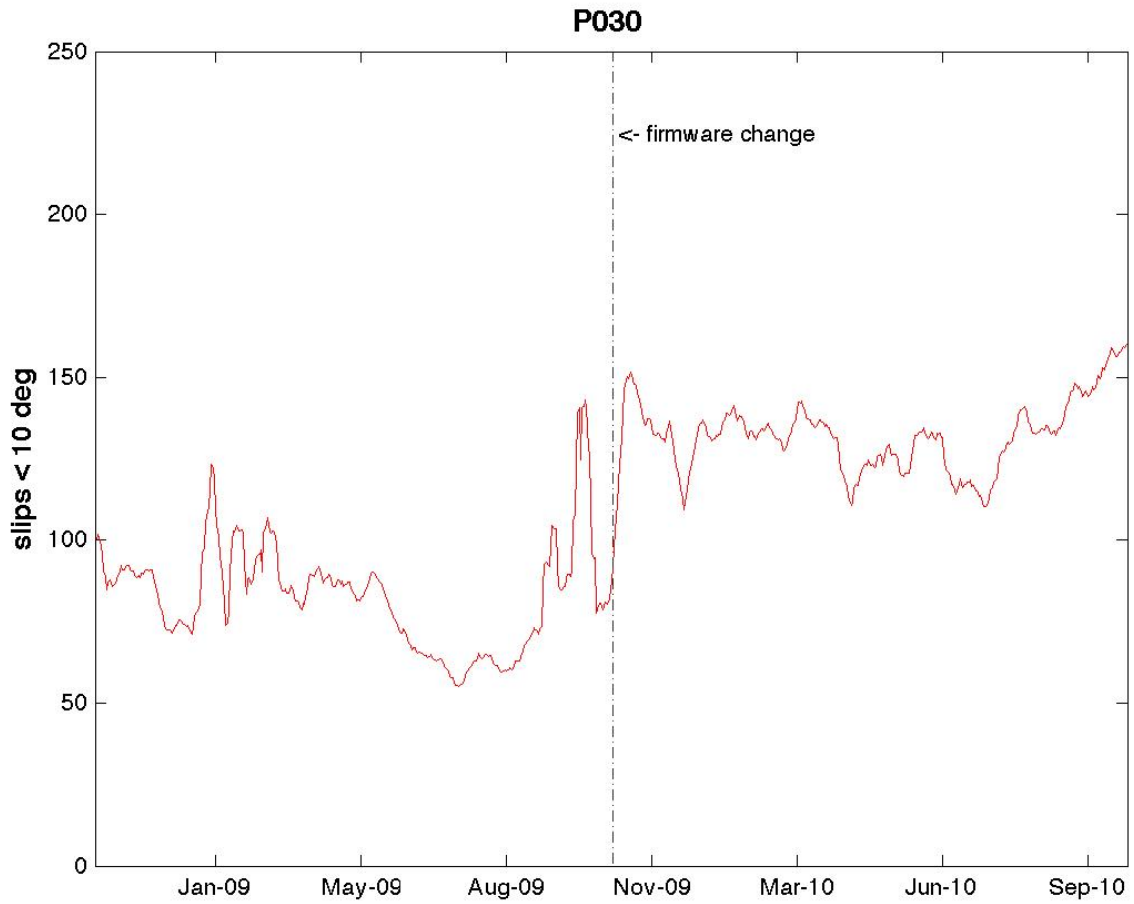
The following figure shows 24-hour totals of MP or IOD slips that occur at the site P030 when the elevation angles were < 10 degrees. The gray dashed line indicates when the receiver firmware at P030 was upgraded from 1.1-2 to 1.3-0. The average number of IOD or MP slips before the firmware change is 83. The average IOD or MP slips after the firmware change is 133.

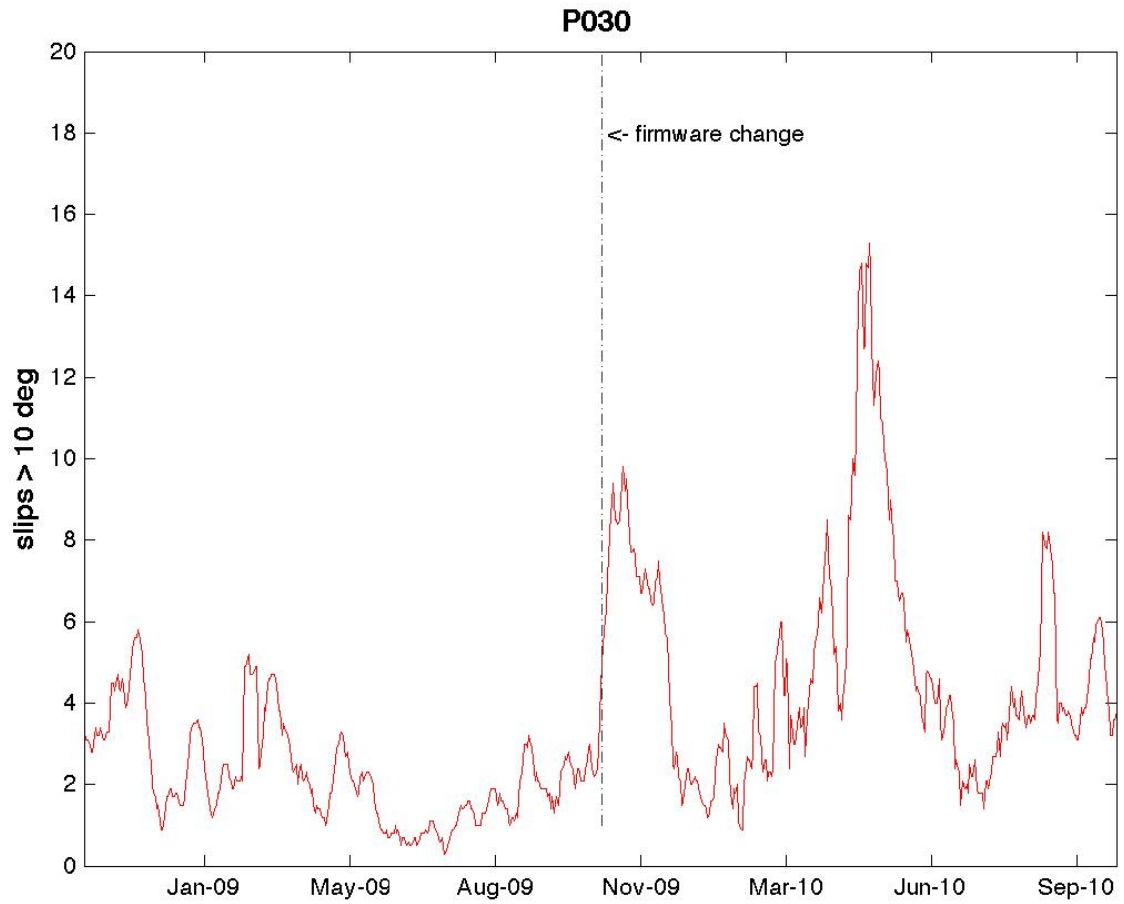
The following figure shows 24-hour totals of MP or IOD slips that occur at the site P030 when the elevation angles were > 10 degrees. The average number of IOD or MP slips before the firmware change is 2.34. The average IOD or MP slips after the firmware change is 4.90.

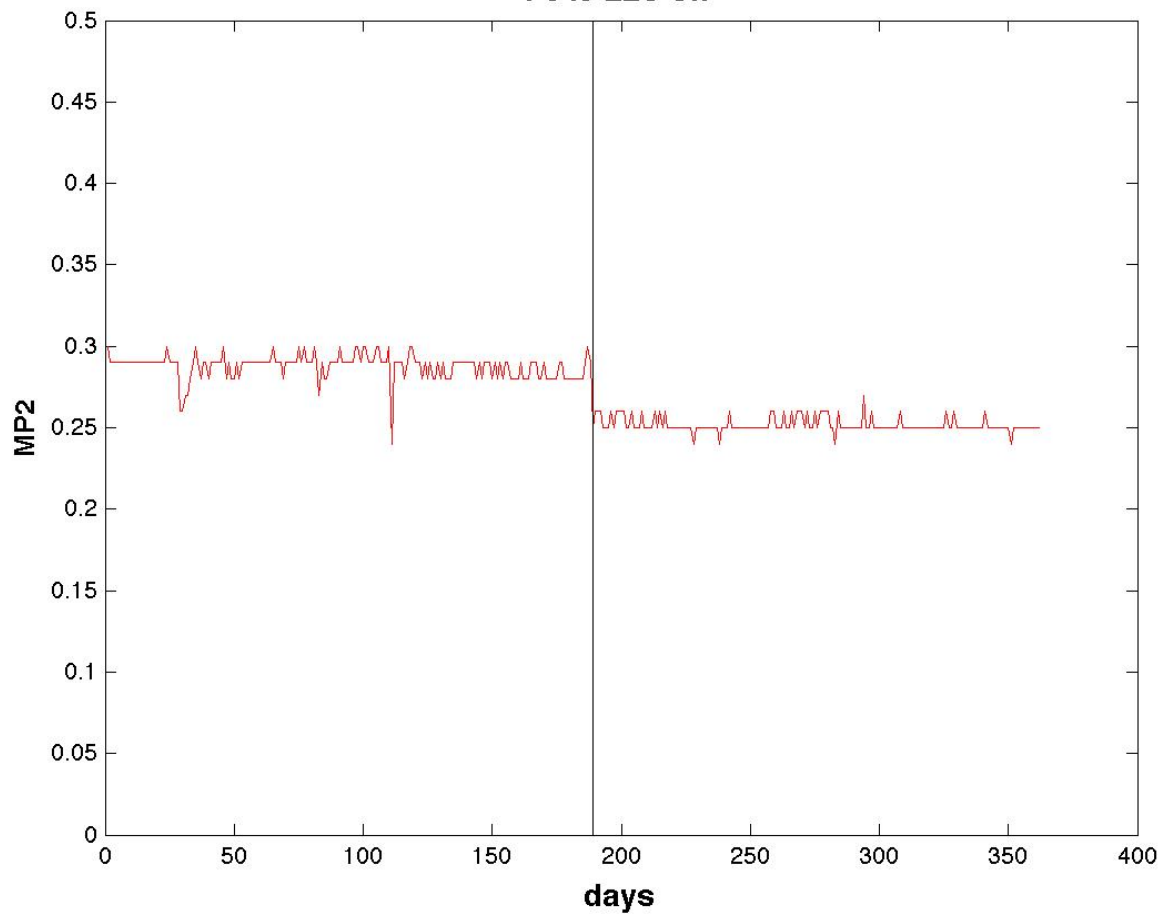
P040 L2C off

We also observed decreases in MP2 values after the firmware was updated at the sites P040 and P030. The figures below shows the MP2 values calculated by Teqc with respect to time.
