Trimble NetRS - tracking behavior changes after firmware upgrade

698 Henry Berglund March 10, 2011 [GNSS Receiver Test Reports, Trimble NetRS](#) 2354

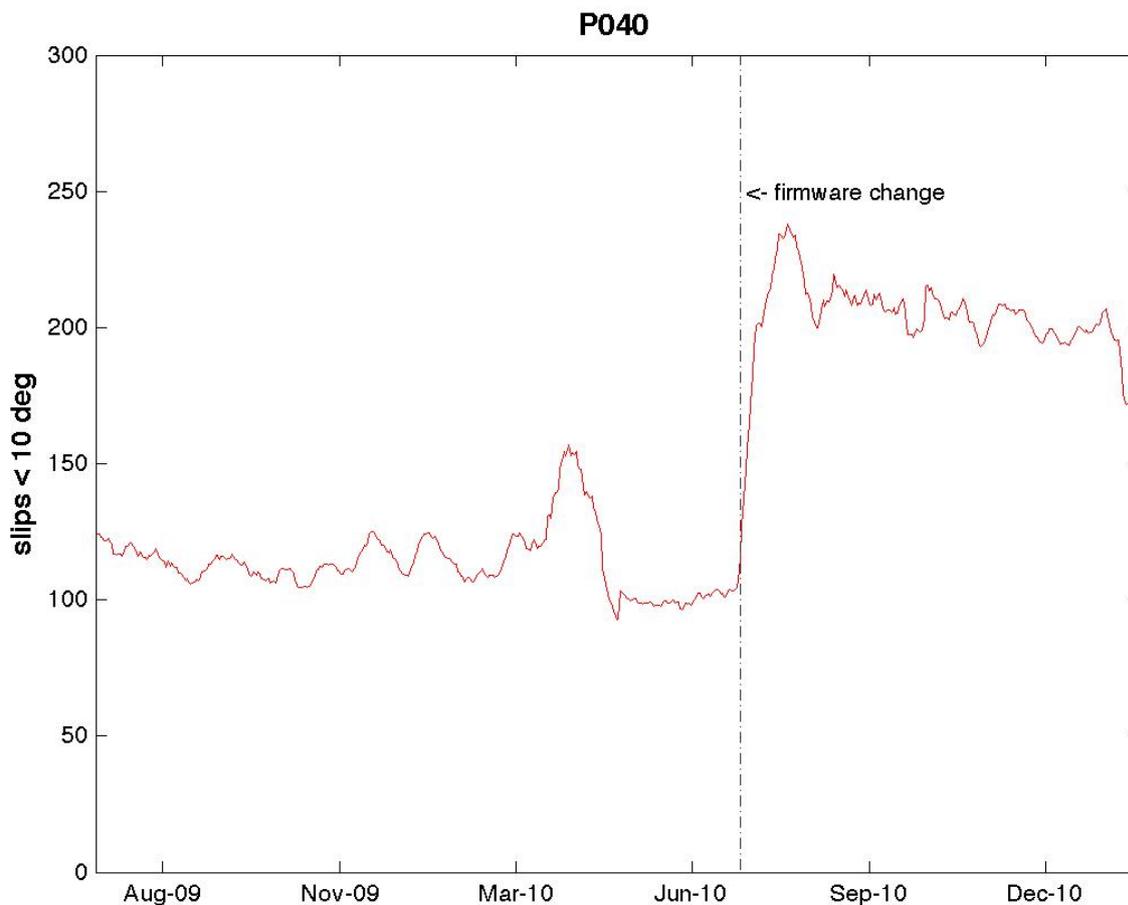
The following figure shows 24-hour totals of MP or IOD slips that occur at the site P040 when the elevation angles were < 10 degrees. The gray dashed line indicates when the receiver firmware at P040 was upgraded from 1.1-2 to 1.3-0. The average number of IOD or MP slips before the firmware change is 113. The average IOD or MP slips after the firmware change is 205.

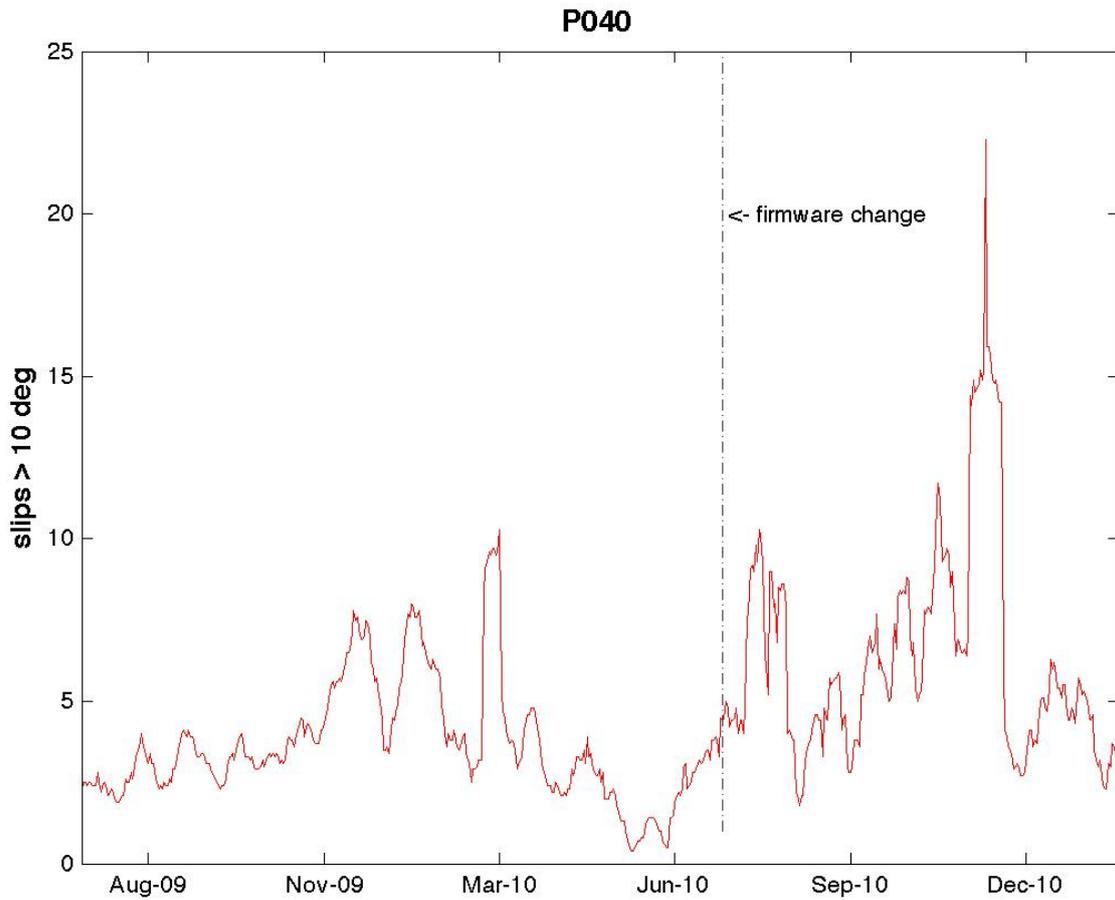
The following figure shows 24-hour totals of MP or IOD slips that occur at the site P040 when the

elevation angles were > 10 degrees. The average number of IOD or MP slips before the firmware change is 3.67. The average IOD or MP slips after the firmware change is 6.33.

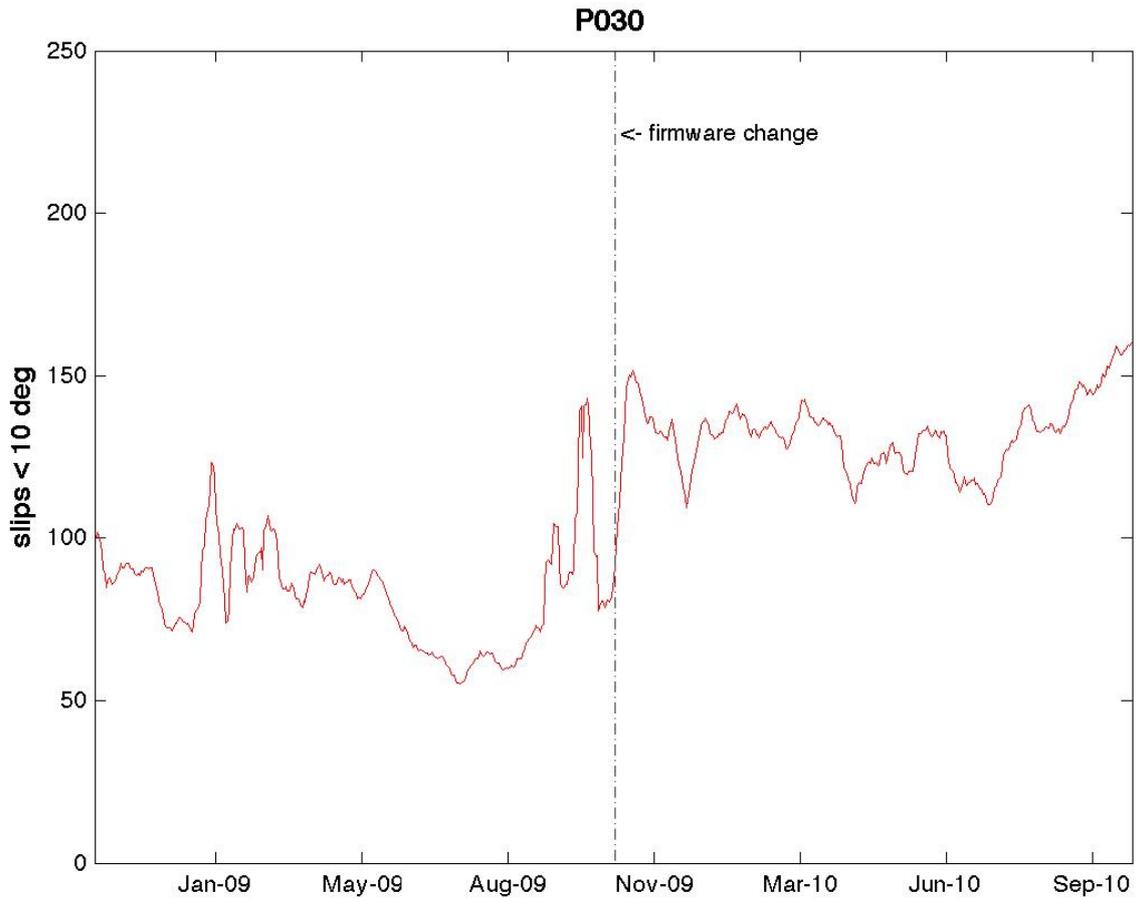
The following figure shows 24-hour totals of MP or IOD slips that occur at the site P030 when the elevation angles were < 10 degrees. The gray dashed line indicates when the receiver firmware at P030 was upgraded from 1.1-2 to 1.3-0. The average number of IOD or MP slips before the firmware change is 83. The average IOD or MP slips after the firmware change is 133.

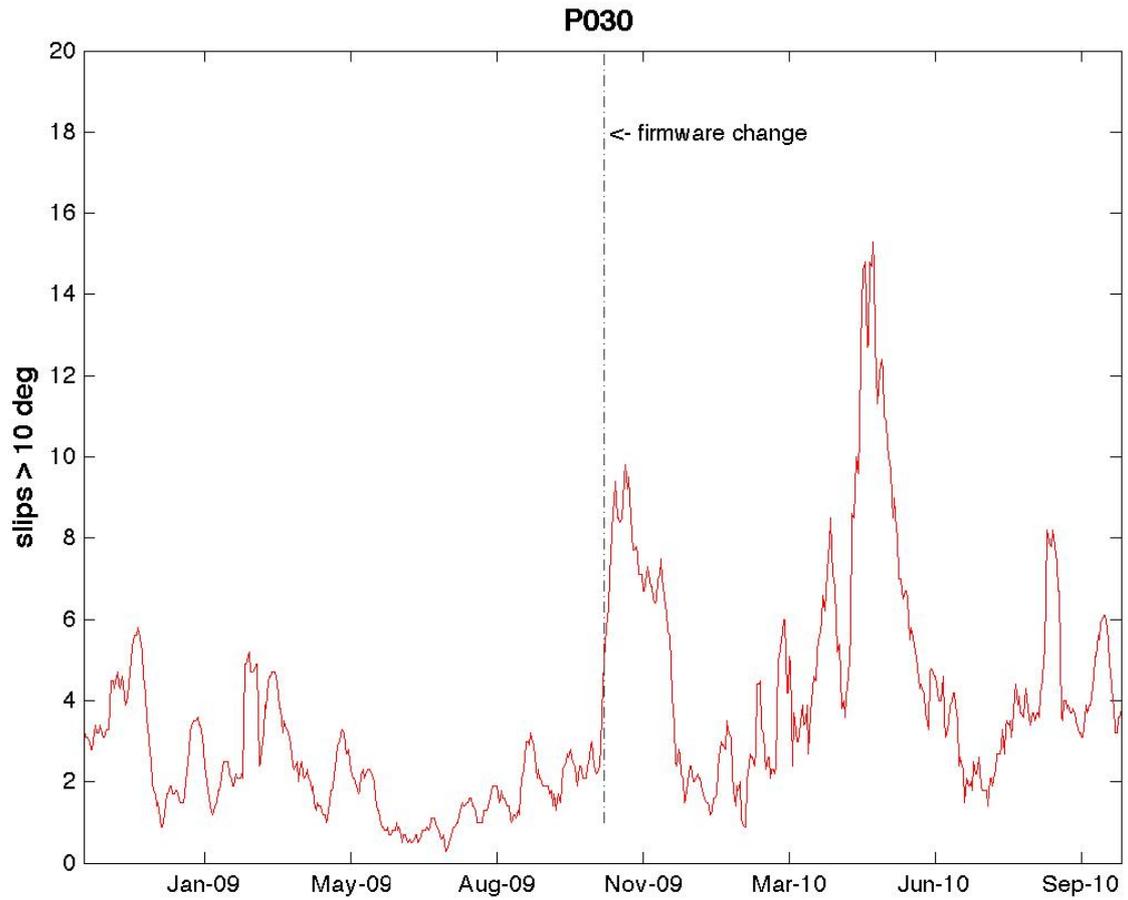
The following figure shows 24-hour totals of MP or IOD slips that occur at the site P030 when the elevation angles were > 10 degrees. The average number of IOD or MP slips before the firmware change is 2.34. The average IOD or MP slips after the firmware change is 4.90.

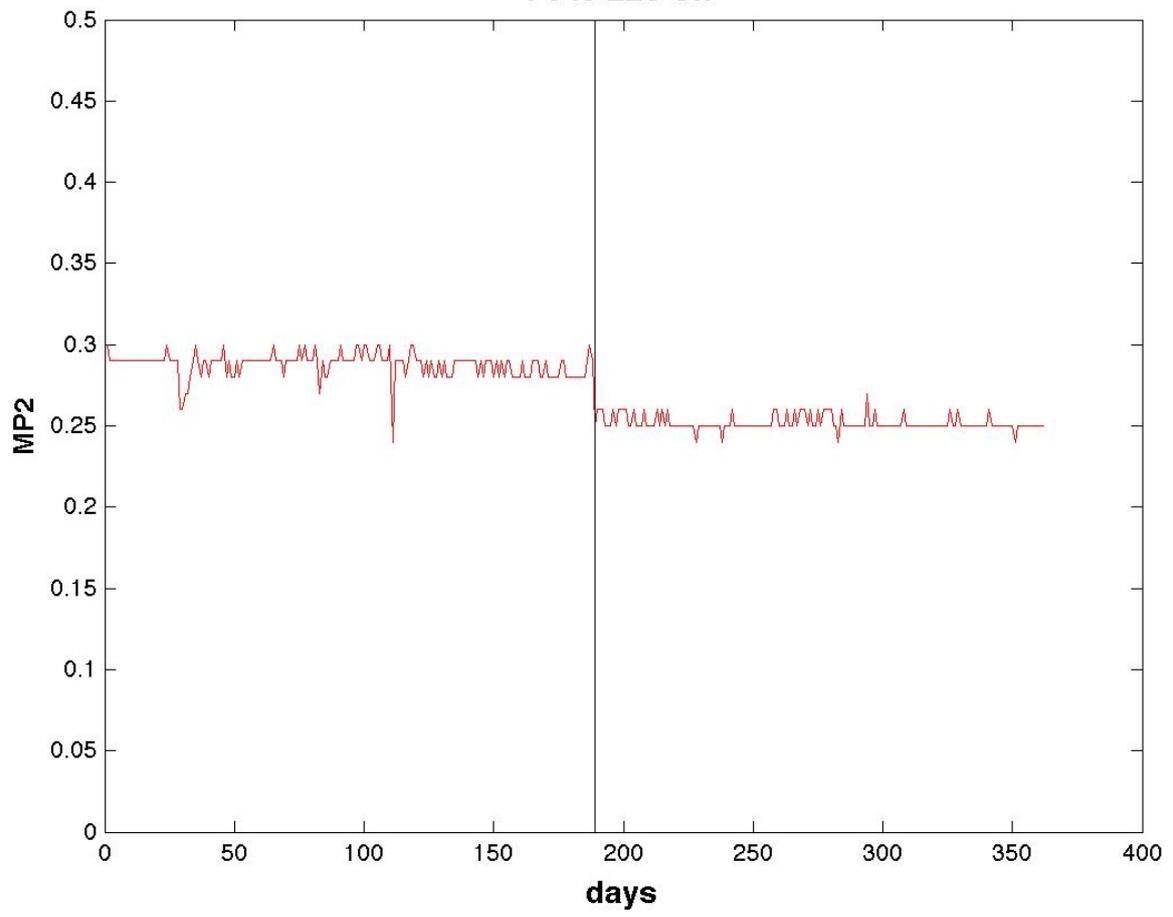
P040 L2C off

We also observed decreases in MP2 values after the firmware was updated at the sites P040 and P030. The figures below shows the MP2 values calculated by Teqc with respect to time.
