# Trimble NetRS - tracking behavior changes after firmware upgrade

698 Henry Berglund March 10, 2011 [GNSS Receiver Test Reports, Trimble NetRS](#) 2067

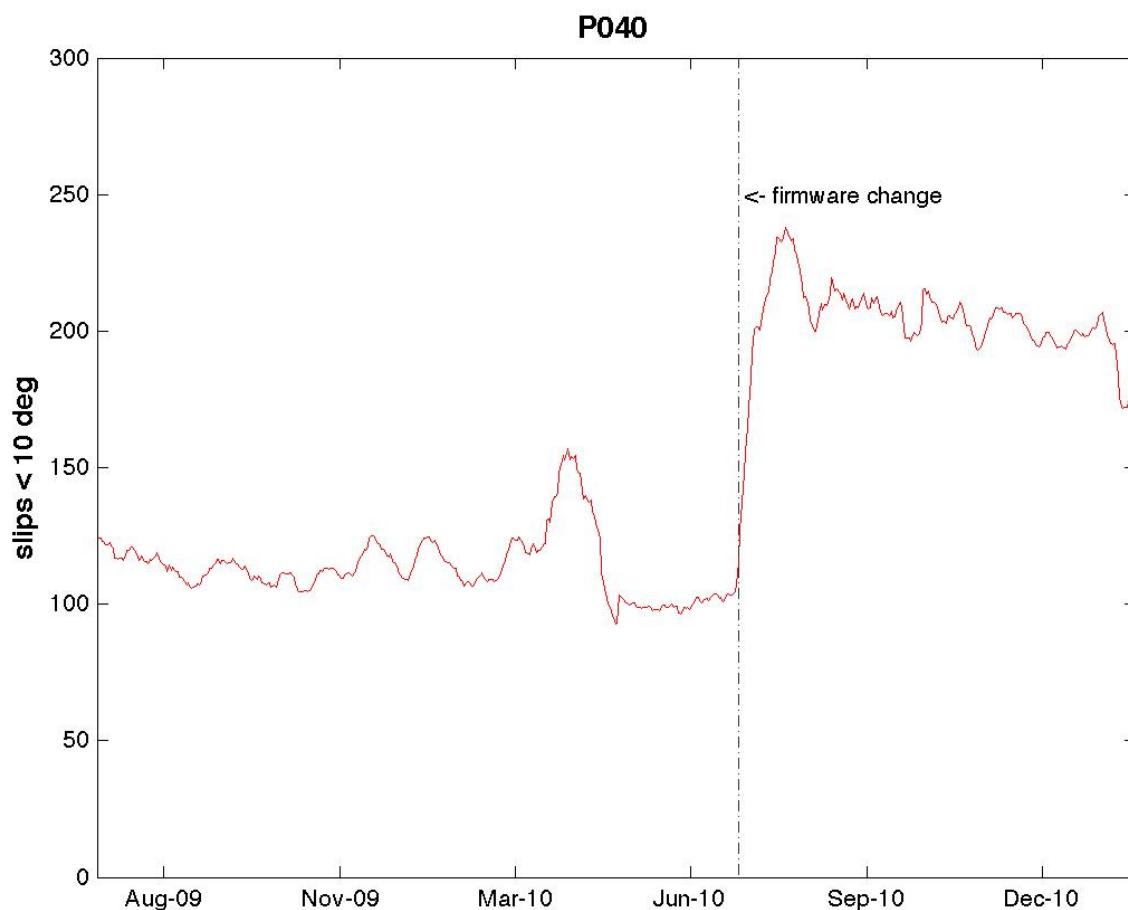
The following figure shows 24-hour totals of MP or IOD slips that occur at the site P040 when the elevation angles were < 10 degrees. The gray dashed line indicates when the receiver firmware at P040 was upgraded from 1.1-2 to 1.3-0. The average number of IOD or MP slips before the firmware change is 113. The average IOD or MP slips after the firmware change is 205.

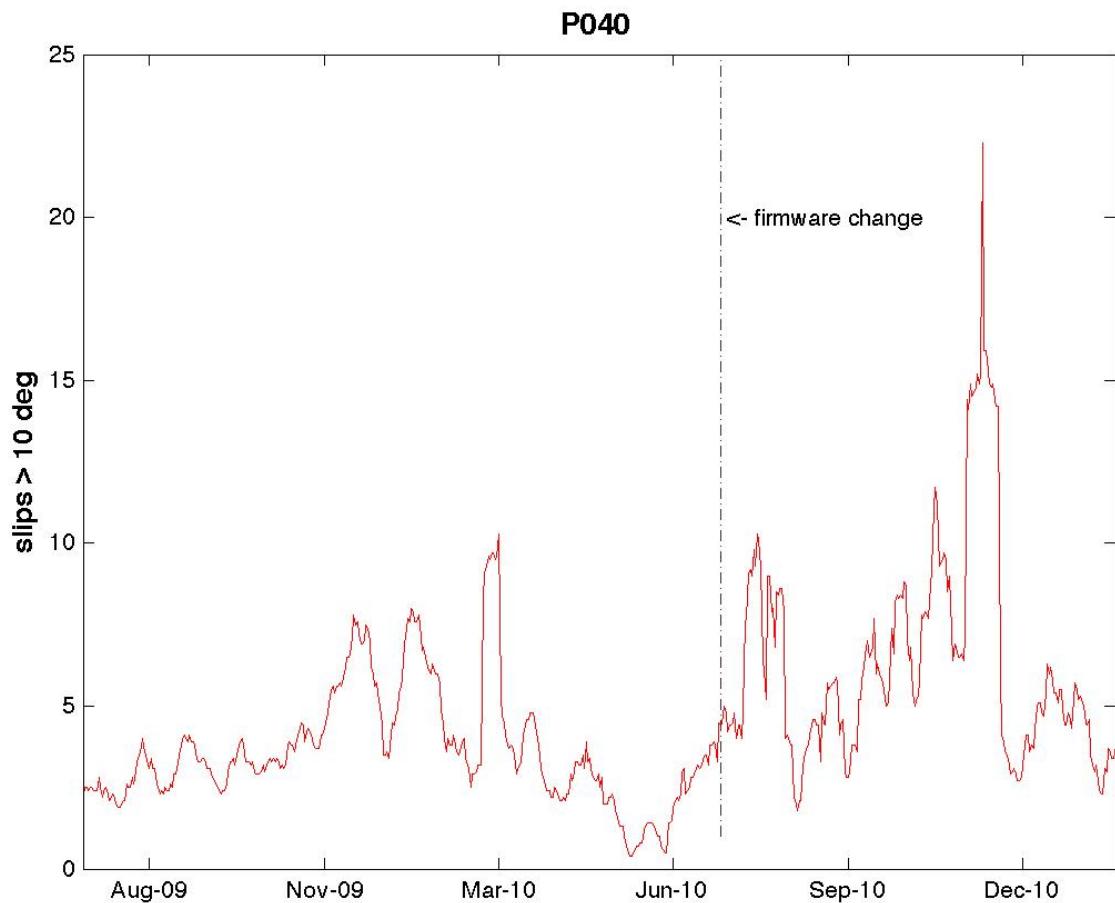
The following figure shows 24-hour totals of MP or IOD slips that occur at the site P040 when the

elevation angles were  $> 10$  degrees. The average number of IOD or MP slips before the firmware change is 3.67. The average IOD or MP slips after the firmware change is 6.33.

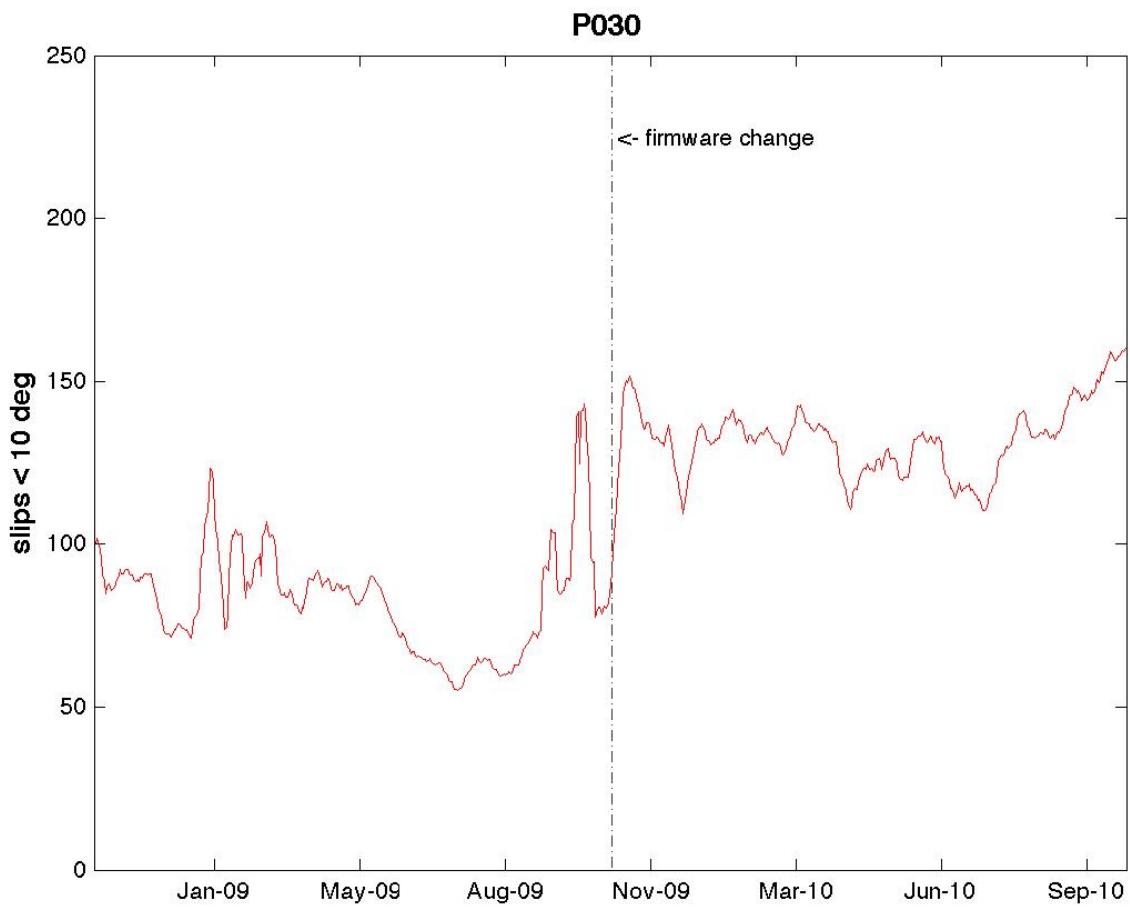
The following figure shows 24-hour totals of MP or IOD slips that occur at the site P030 when the elevation angles were  $< 10$  degrees. The gray dashed line indicates when the receiver firmware at P030 was upgraded from 1.1-2 to 1.3-0. The average number of IOD or MP slips before the firmware change is 83. The average IOD or MP slips after the firmware change is 133.

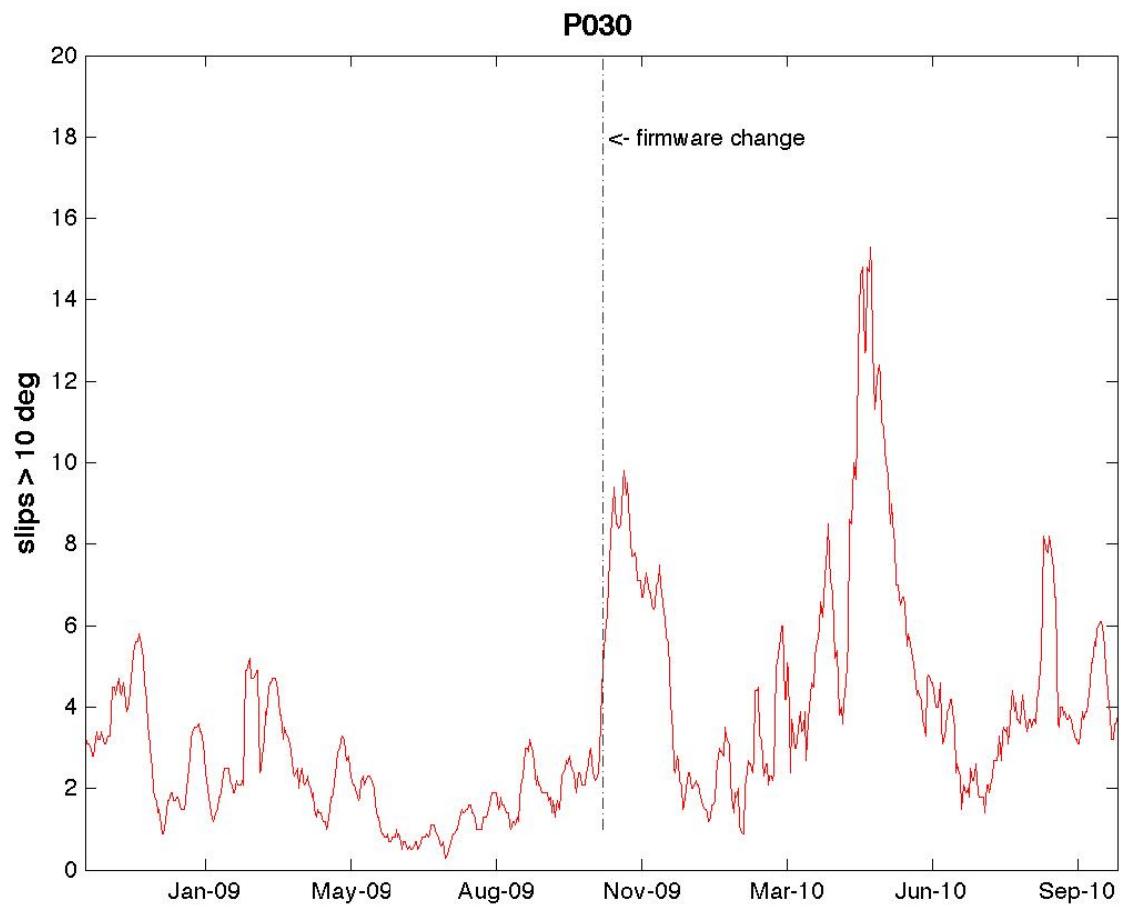
The following figure shows 24-hour totals of MP or IOD slips that occur at the site P030 when the elevation angles were  $> 10$  degrees. The average number of IOD or MP slips before the firmware change is 2.34. The average IOD or MP slips after the firmware change is 4.90.

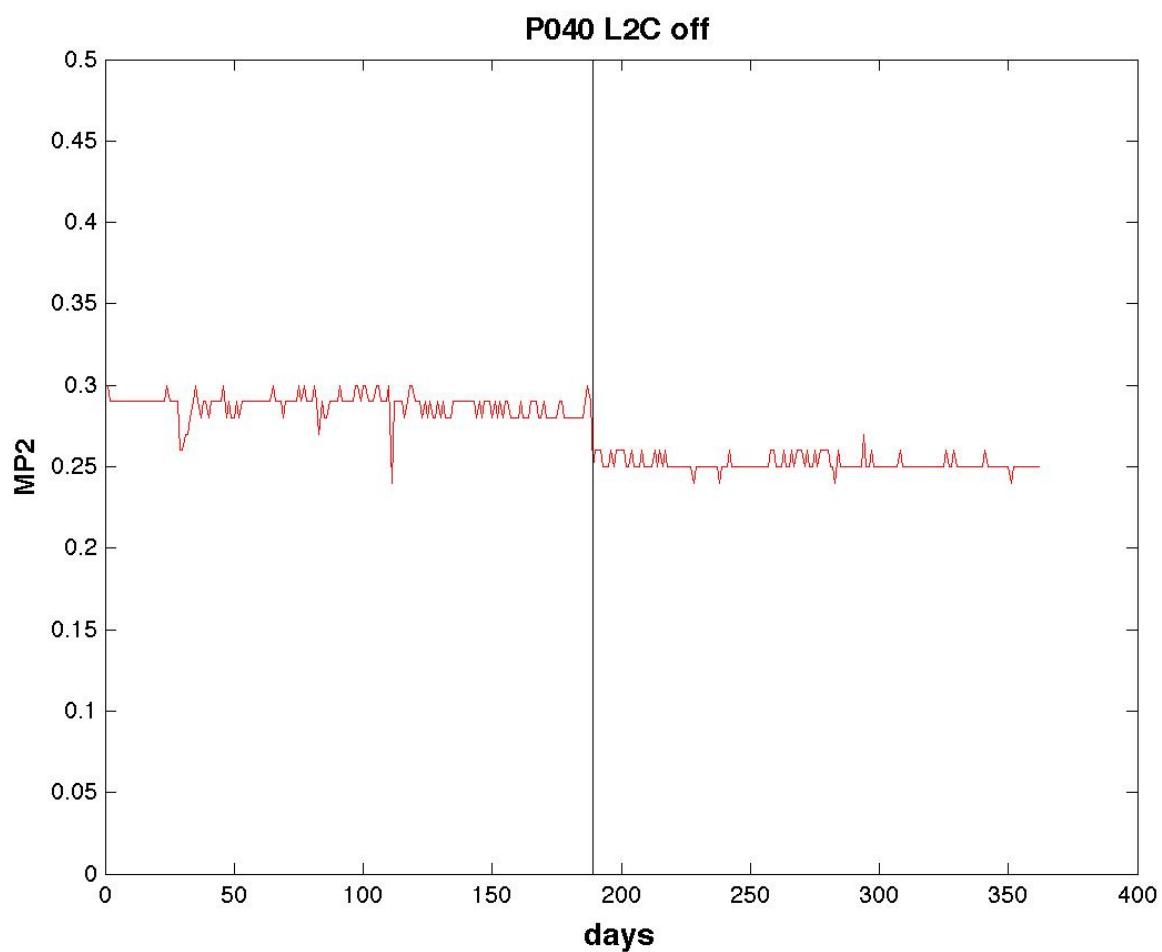
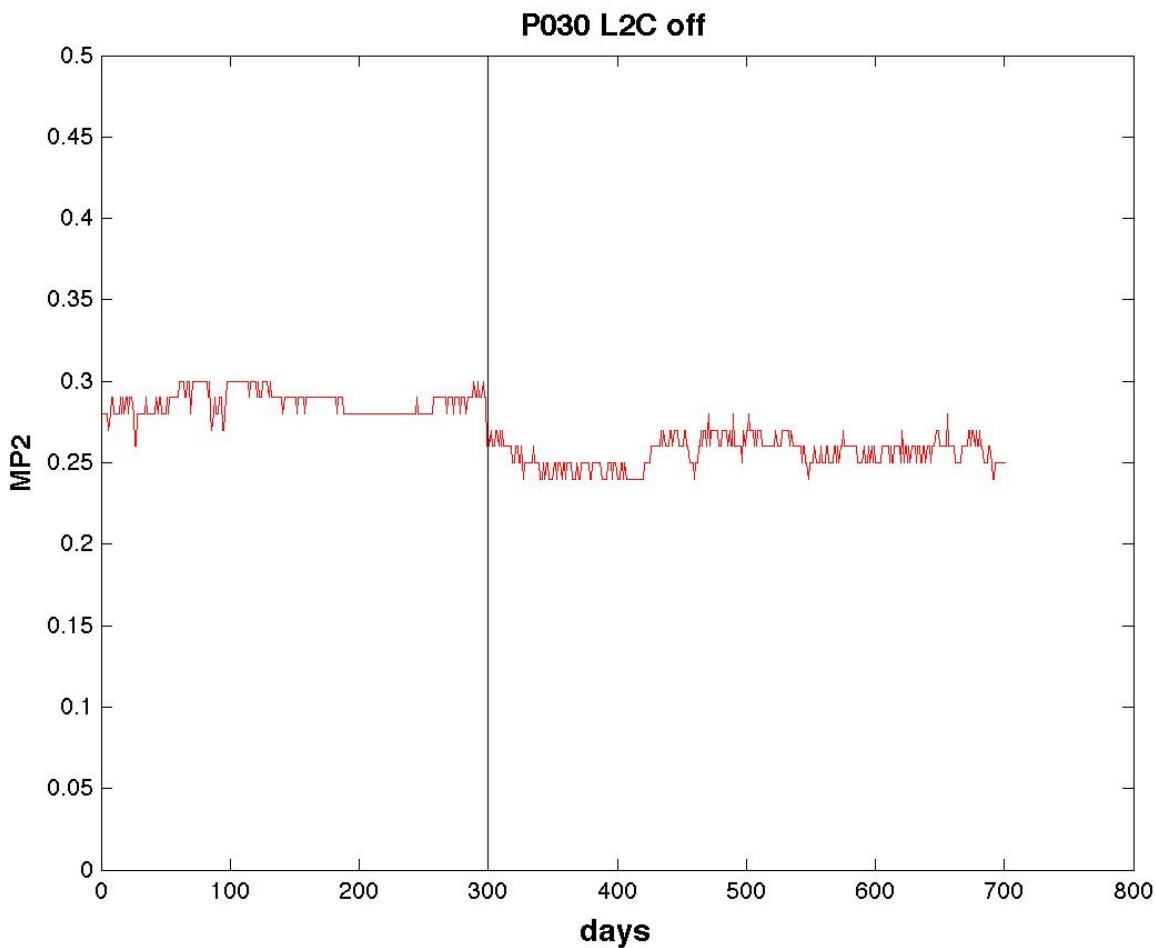
We also observed decreases in MP2 values after the firmware was updated at the sites P040 and P030. The figures below shows the MP2 values calculated by Teqc with respect to time.
