Trimble NetRS - tracking behavior changes after firmware upgrade

698 Henry Berglund March 10, 2011 [GNSS Receiver Test Reports](#), [Trimble NetRS](#) 1448

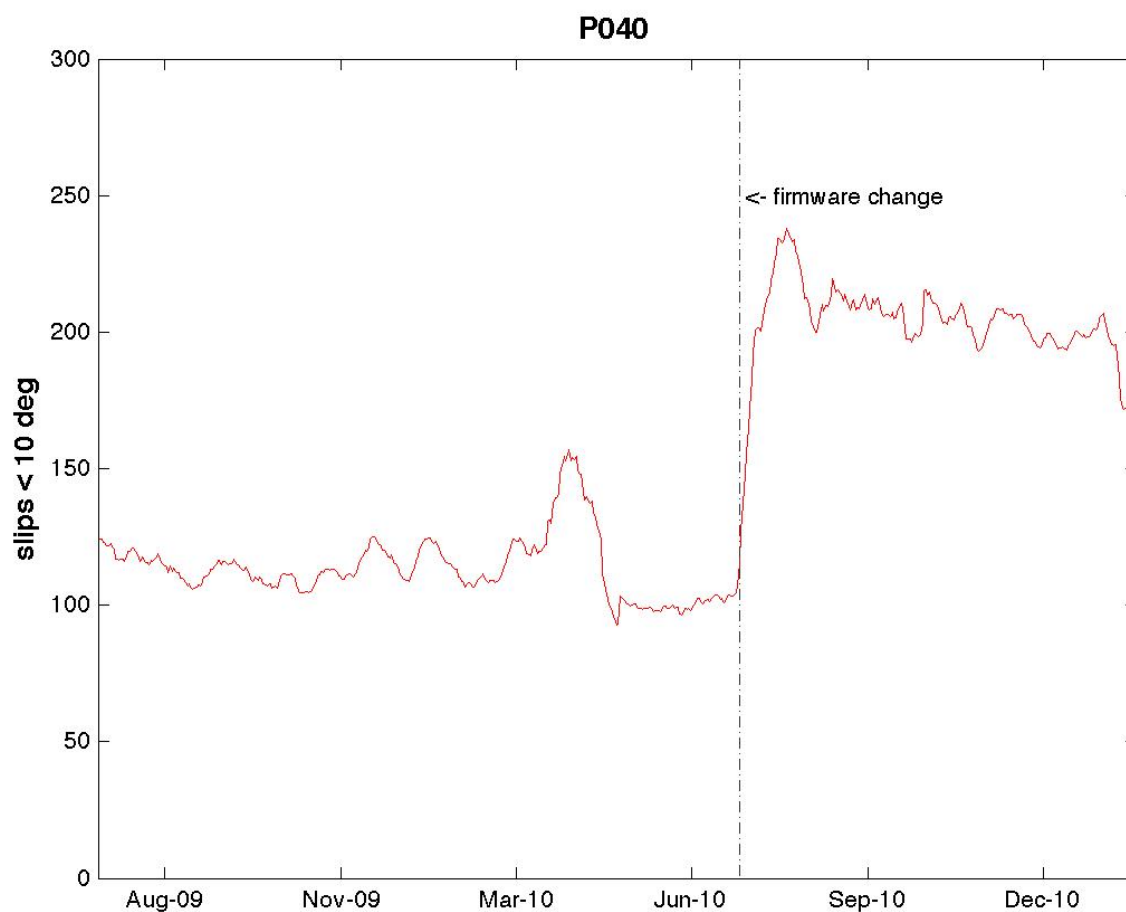
The following figure shows 24-hour totals of MP or IOD slips that occur at the site P040 when the elevation angles were < 10 degrees. The gray dashed line indicates when the receiver firmware at P040 was upgraded from 1.1-2 to 1.3-0. The average number of IOD or MP slips before the firmware change is 113. The average IOD or MP slips after the firmware change is 205.
