Trimble NetRS - tracking behavior changes after firmware upgrade

698 Henry Berglund March 10, 2011 GNSS Receiver Test Reports, Trimble NetRS 1888

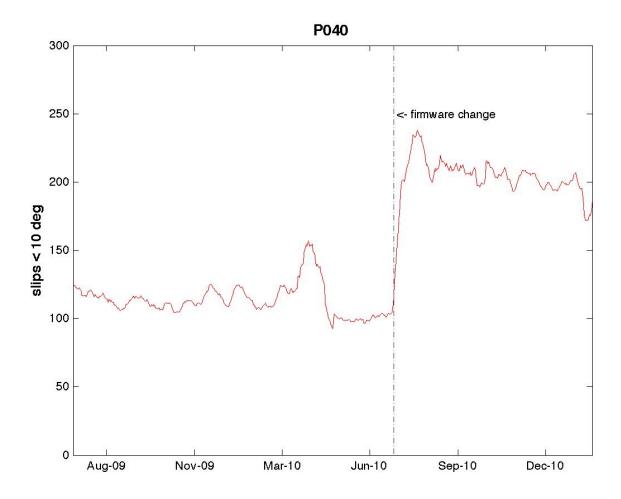
The following figure shows 24-hour totals of MP or IOD slips that occur at the site P040 when the elevation angles were < 10 degrees. The gray dashed line indicates when the receiver firmware at P040 was upgraded from 1.1-2 to 1.3-0. The average number of IOD or MP slips before the firmware change is 113. The average IOD or MP slips after the firmware change is 205.

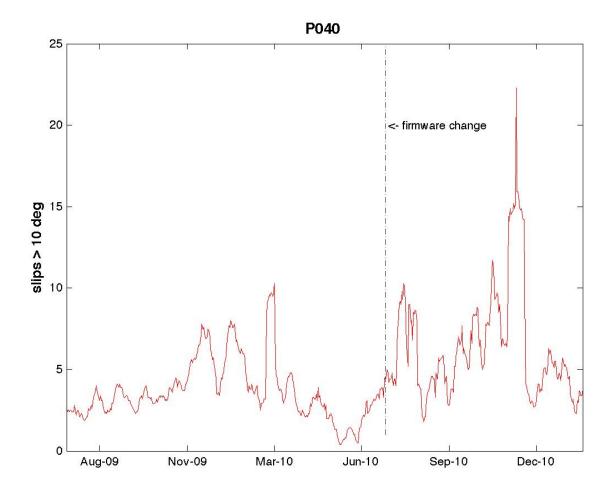
The following figure shows 24-hour totals of MP or IOD slips that occur at the site P040 when the

elevation angles were > 10 degrees. The average number of IOD or MP slips before the firmware change is 3.67. The average IOD or MP slips after the firmware change is 6.33.

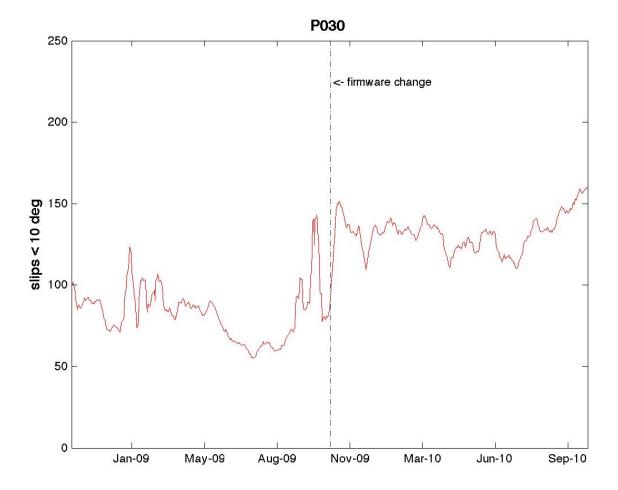
The following figure shows 24-hour totals of MP or IOD slips that occur at the site P030 when the elevation angles were < 10 degrees. The gray dashed line indicates when the receiver firmware at P030 was upgraded from 1.1-2 to 1.3-0. The average number of IOD or MP slips before the firmware change is 83. The average IOD or MP slips after the firmware change is 133.

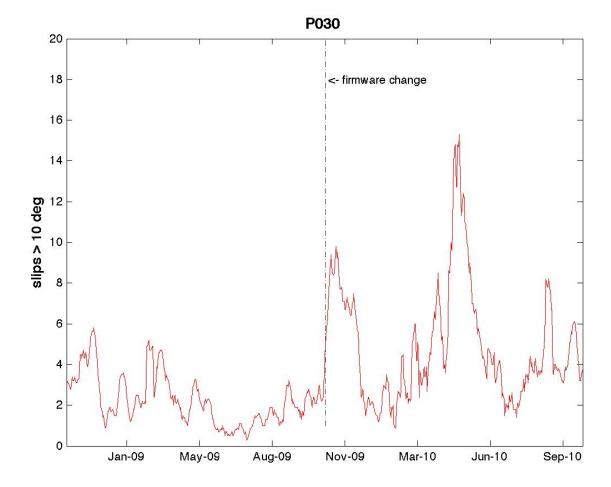
The following figure shows 24-hour totals of MP or IOD slips that occur at the site P030 when the elevation angles were > 10 degrees. The average number of IOD or MP slips before the firmware change is 2.34. The average IOD or MP slips after the firmware change is 4.90.

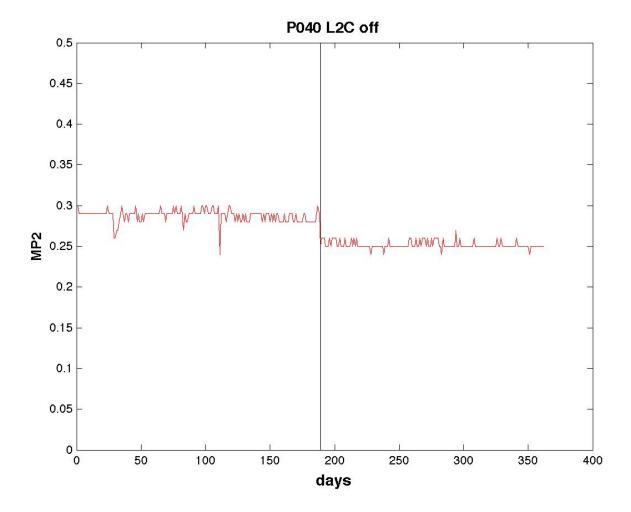
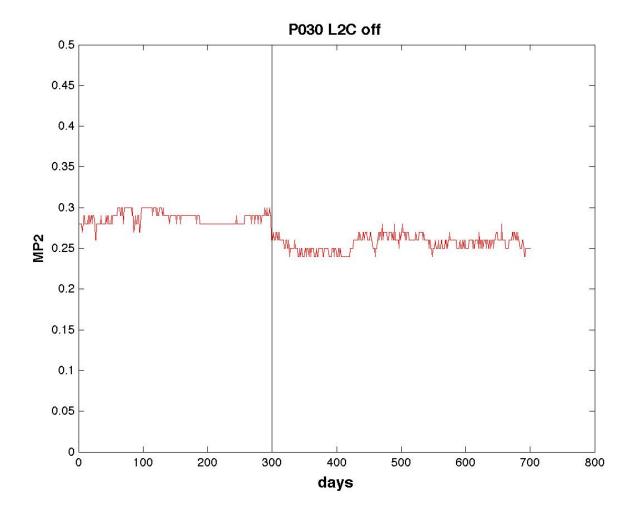
We also observed decreases in MP2 values after the firmware was updated at the sites P040 and P030. The figures below shows the MP2 values calculated by Teqc with respect to time.
