Vaisala WXT-520 important service notice

782 Jim Normandeau June 12, 2013 [Vaisala](#) 686

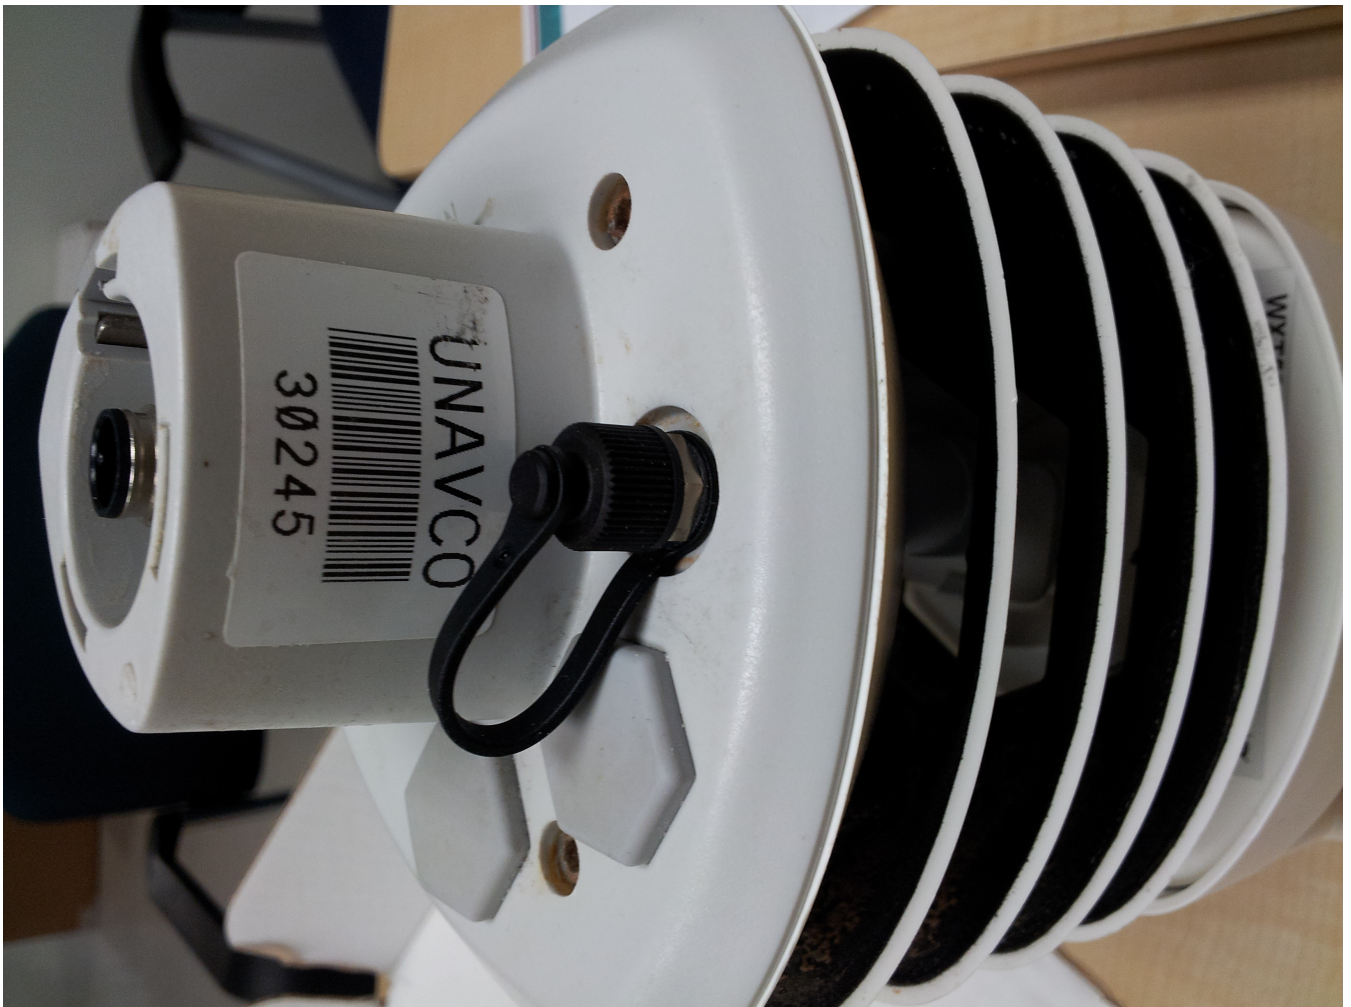
The Vaisala engineers determined that the cause is due to moisture getting into the service port.

The moisture was shorting out this port and thus shutting down the serial port.

They have come up with a new more robust connector and will be installing it on future units.
