Vaisala WXT-520 important service notice

782 Jim Normandeau June 12, 2013 [Vaisala](#) 1133

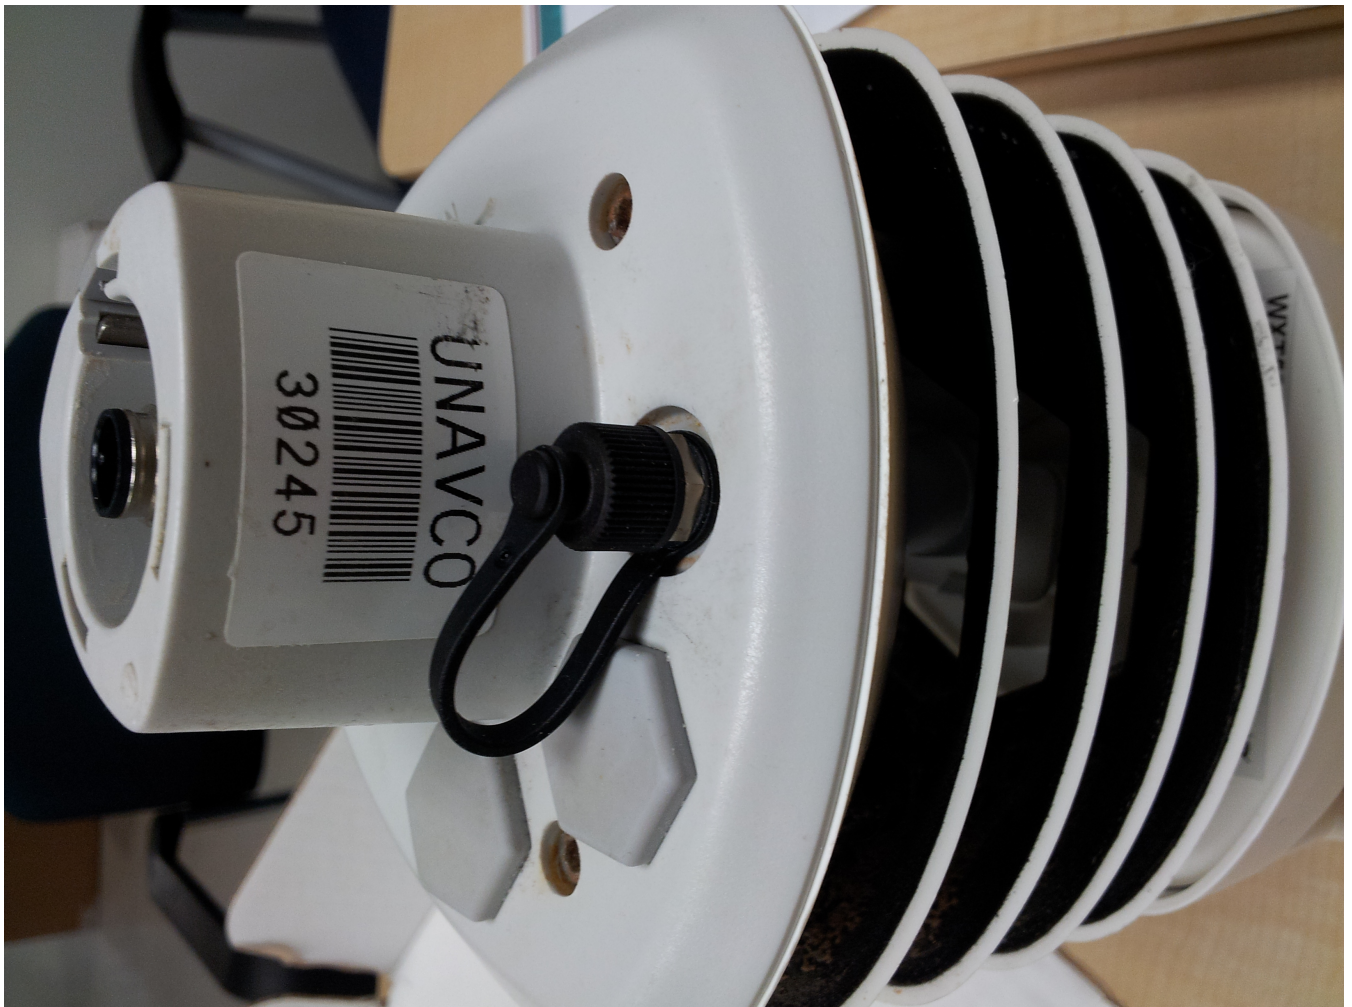
There has been a high number of met pack failures.

The Vaisala engineers determined that the cause is due to moisture getting into the service port.

The moisture was shorting out this port and thus shutting down the serial port.

They have come up with a new more robust connector and will be installing it on future units.
