Vaisala WXT-520 important service notice

782 Jim Normandeau June 12, 2013 [Vaisala](#) 1637

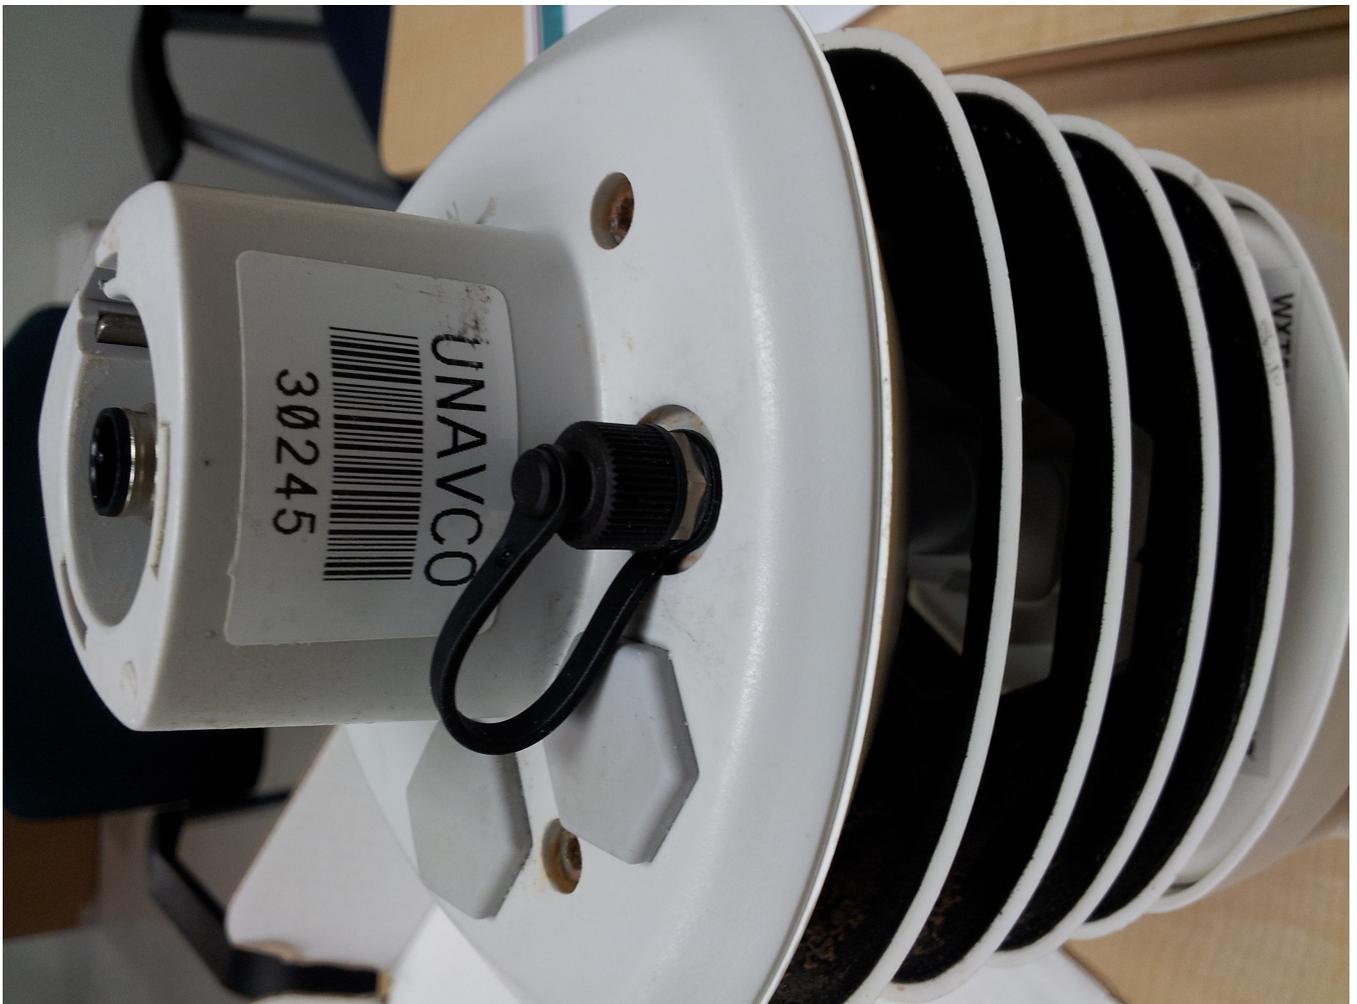
There has been a high number of met pack failures.

The Vaisala engineers determined that the cause is due to moisture getting into the service port.

The moisture was shorting out this port and thus shutting down the serial port.

They have come up with a new more robust connector and will be installing it on future units.
