# Vaisala WXT-520 important service notice

782 Jim Normandeau June 12, 2013 [Vaisala](#) 1499

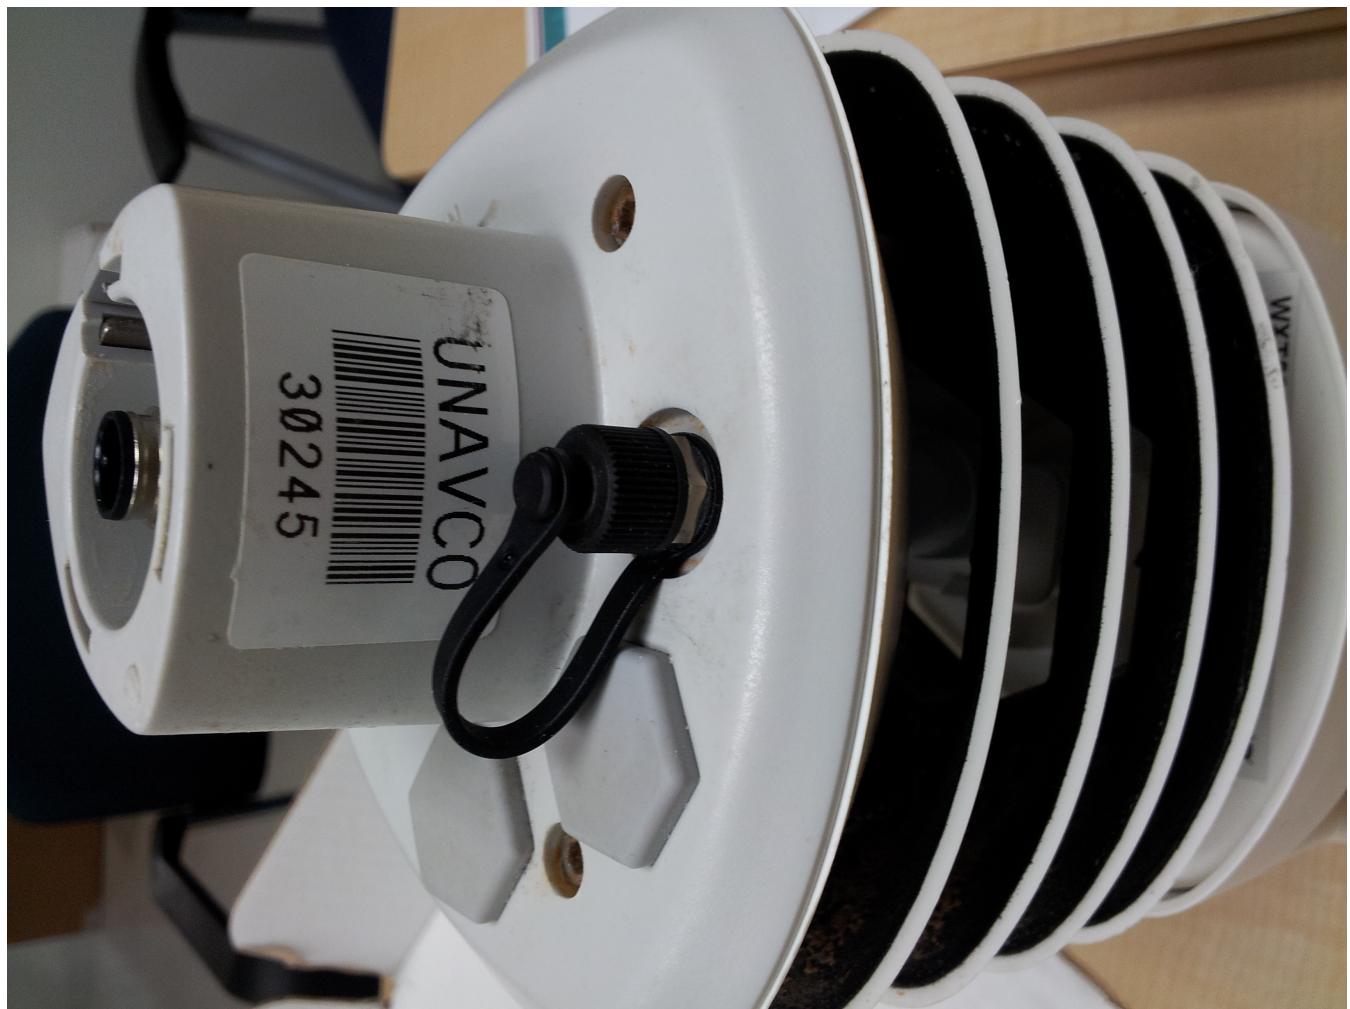
There has been a high number of met pack failures.

The Vaisala engineers determined that the cause is due to moisture getting into the service port.

The moisture was shorting out this port and thus shutting down the serial port.

They have come up with a new more robust connector and will be installing it on future units.
