Vaisala WXT-520 important service notice

782 Jim Normandeau June 12, 2013 Vaisala 1356

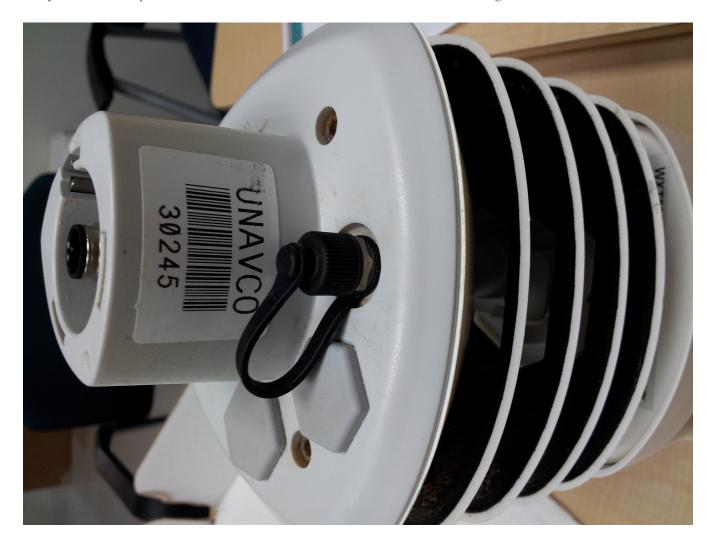
There has been a high number of met pack failures.

The Vaisala engineers determined that the cause is due to moisture getting into the service port.

The moisture was shorting out this port and thus shutting down the serial port.

They have come up with a new more robust connector and will be installing it on future units.
