Firmware glitch affects Trimble NetRS Receivers on 31 October, 2010

676 Freddy Blume November 23, 2015 <u>Trimble NetRS</u> 2011

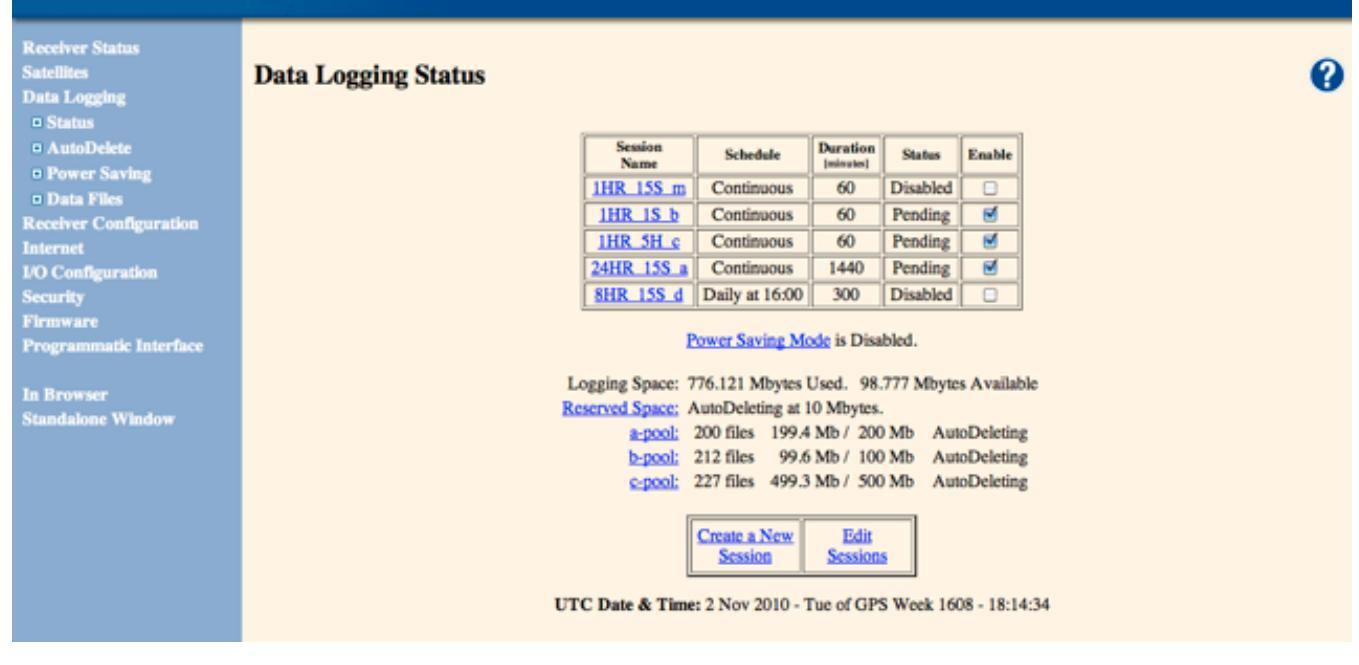
NetRS CPBN SN4518249779

4. System stops tracking SV's and logging data but does not restart:

Error messages appear in the system logs, many processes crash, but a restart is NOT triggered. Receiver is left in a state that its web server is accessible, but is not tracking or logging, and data sessions revert to "Pending" instead of active (see the screen shots below for examples). The active data files at the time continue to show as being active in most cases. Data reports for these receivers will show either 8% or zero for 10/31 and zeros for 11/1 and 11/2. THESE STATIONS REQUIRE REBOOTS either via the web interface or by cycling power to resume normal operation. After the user restarts the receiver the data files from 10/31 have been preserved. About 5% of the UNAVCO-operated NetRS population exhibited this behavior.

If you encounter receivers in this state, go to the "Receiver Configuration -> System Reset" and do a simple restart.
