Trimble NetRS - tracking behavior changes after firmware upgrade

698 Henry Berglund March 10, 2011 [GNSS Receiver Test Reports, Trimble NetRS](#) 2291

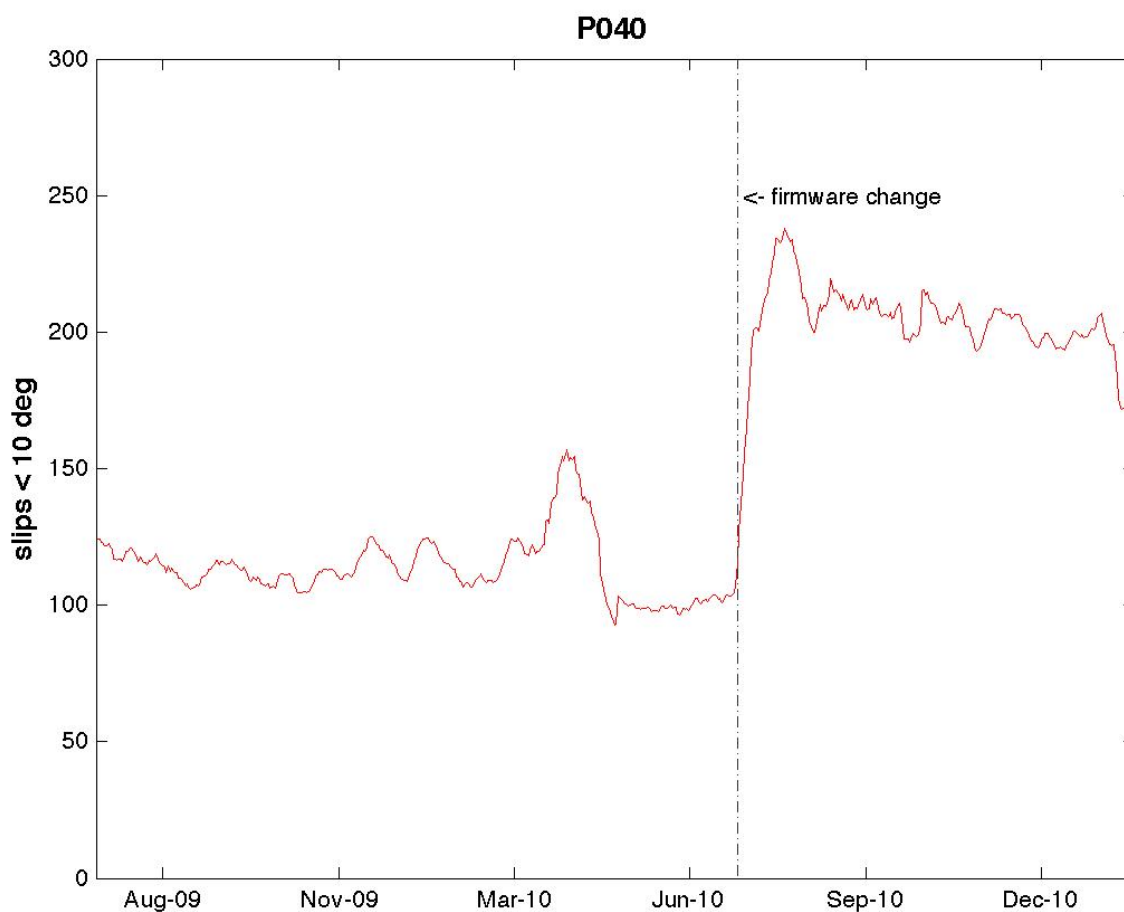
The following figure shows 24-hour totals of MP or IOD slips that occur at the site P040 when the elevation angles were < 10 degrees. The gray dashed line indicates when the receiver firmware at P040 was upgraded from 1.1-2 to 1.3-0. The average number of IOD or MP slips before the firmware change is 113. The average IOD or MP slips after the firmware change is 205.
