Trimble NetRS - tracking behavior changes after firmware upgrade

698 Henry Berglund March 10, 2011 GNSS Receiver Test Reports, Trimble NetRS 1492

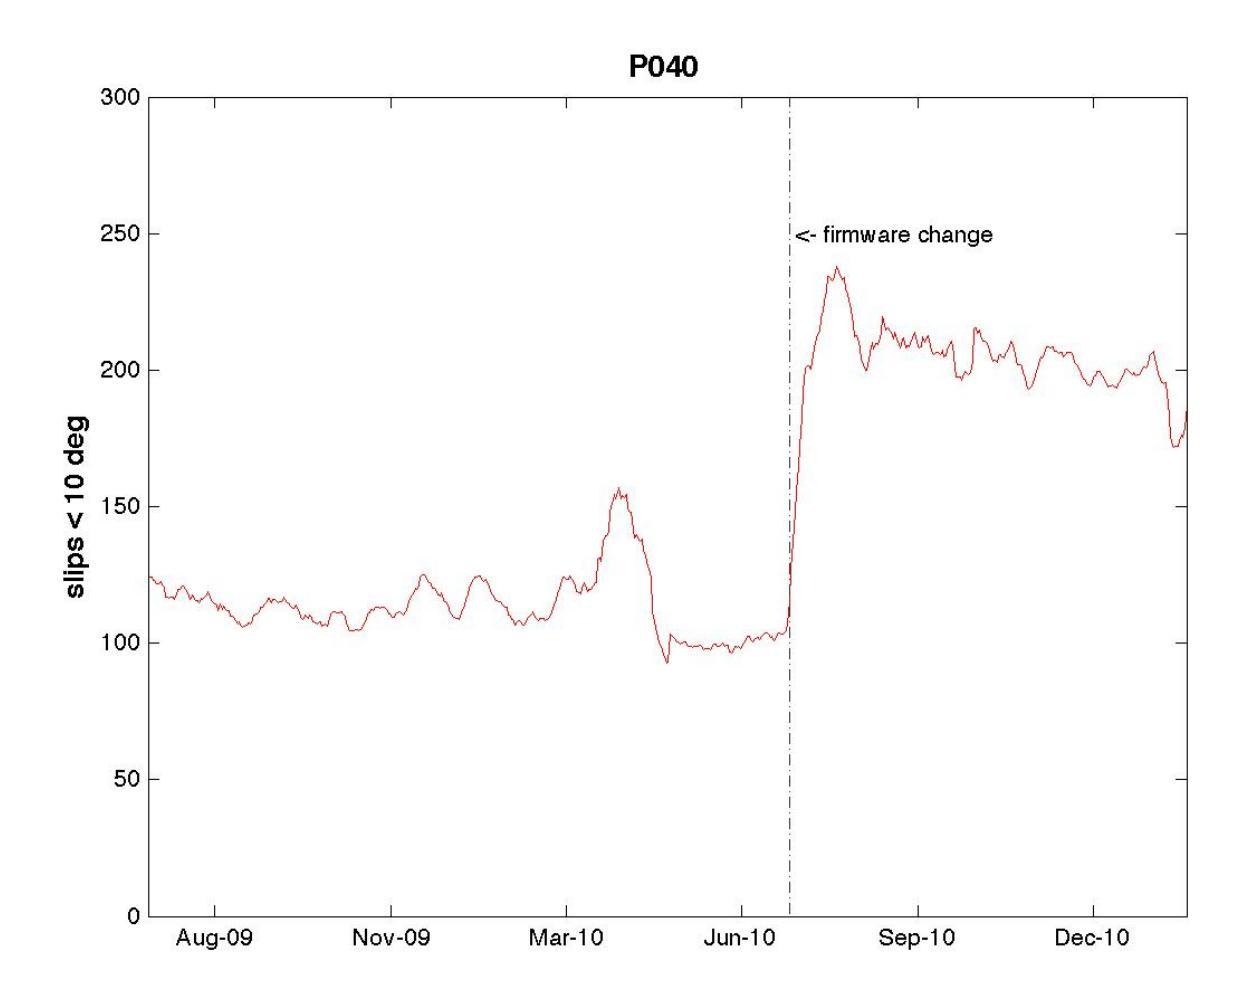
The following figure shows 24-hour totals of MP or IOD slips that occur at the site P040 when the elevation angles were < 10 degrees. The gray dashed line indicates when the receiver firmware at P040 was upgraded from 1.1-2 to 1.3-0. The average number of IOD or MP slips before the firmware change is 113. The average IOD or MP slips after the firmware change is 205.

| P040 | | |
|---|---|---|
| Average IOD or MP slips < 10 degrees | Before fw change: 113 | After fw change: 205 |

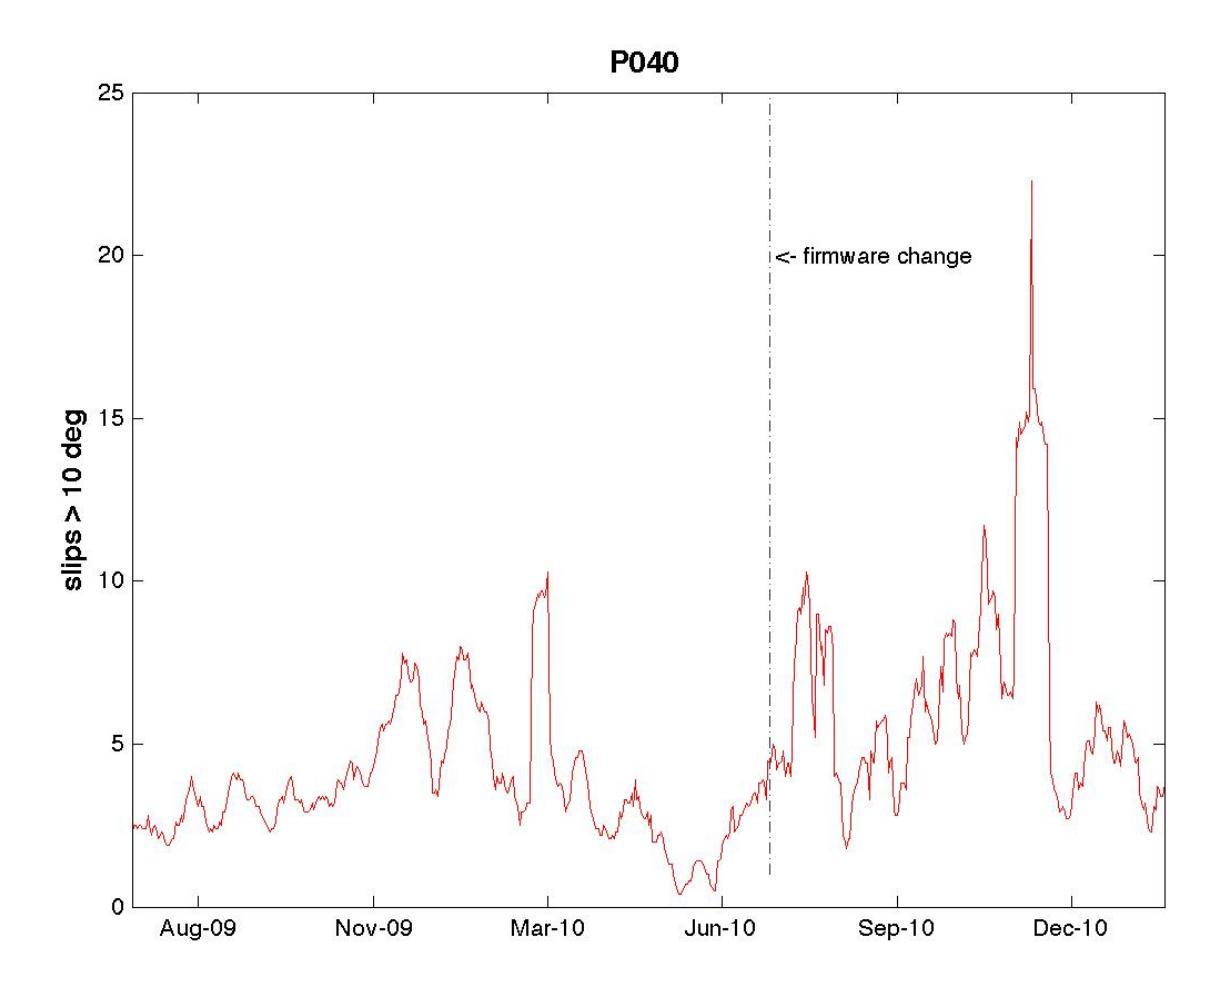
The following figure shows 24-hour totals of MP or IOD slips that occur at the site P040 when the

elevation angles were > 10 degrees. The average number of IOD or MP slips before the firmware change is 3.67. The average IOD or MP slips after the firmware change is 6.33.

| P040 | | |
|---|---|---|
| Average IOD or MP slips > 10 degrees | Before fw change: 3.67 | After fw change: 6.33 |

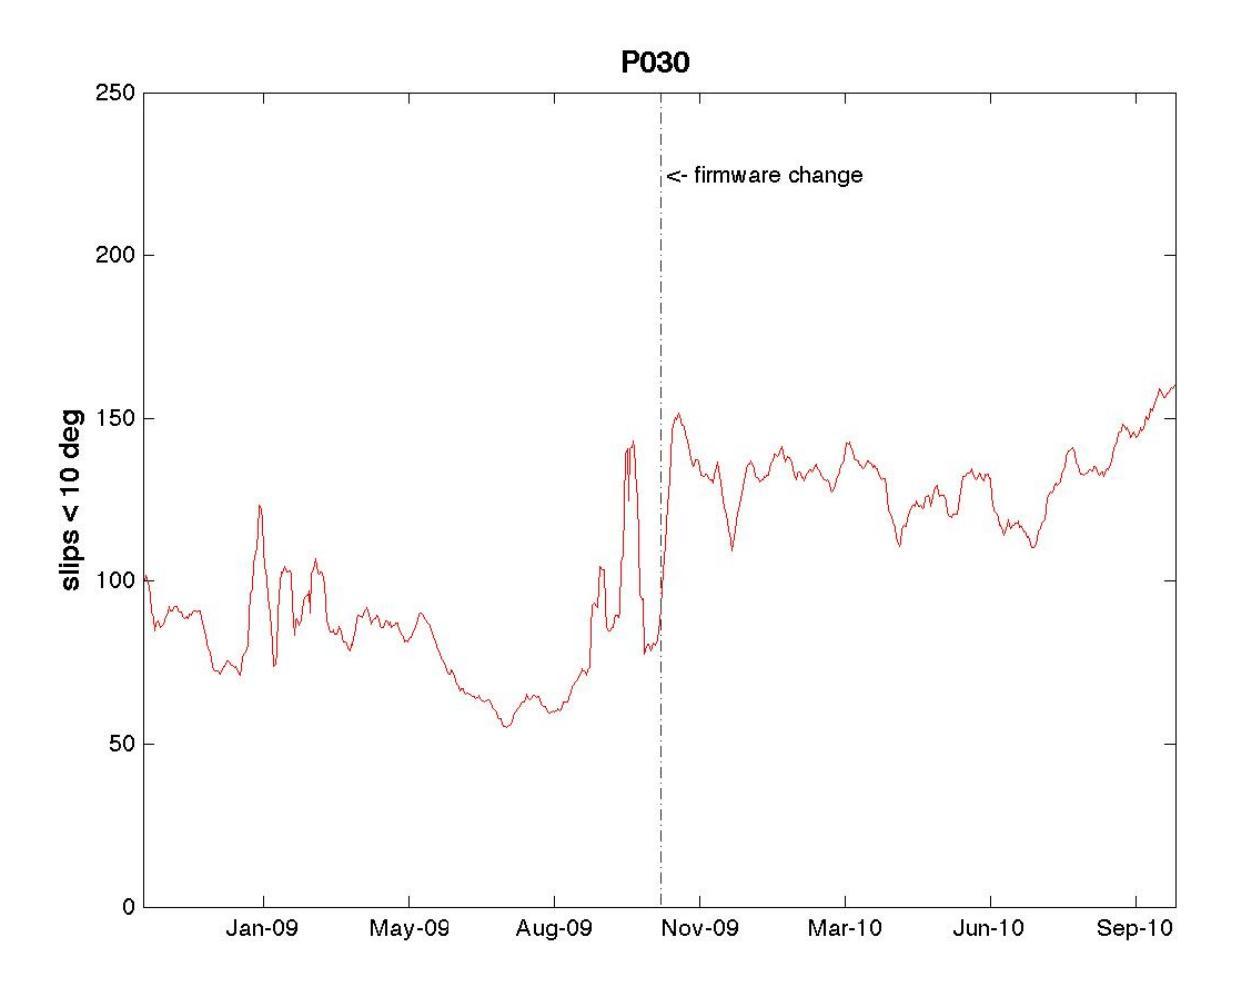
The following figure shows 24-hour totals of MP or IOD slips that occur at the site P030 when the elevation angles were < 10 degrees. The gray dashed line indicates when the receiver firmware at P030 was upgraded from 1.1-2 to 1.3-0. The average number of IOD or MP slips before the firmware change is 83. The average IOD or MP slips after the firmware change is 133.

| P040 | | |
|---|---|---|
| Average IOD or MP slips < 10 | Before fw change: 83 | After fw change: 133 |

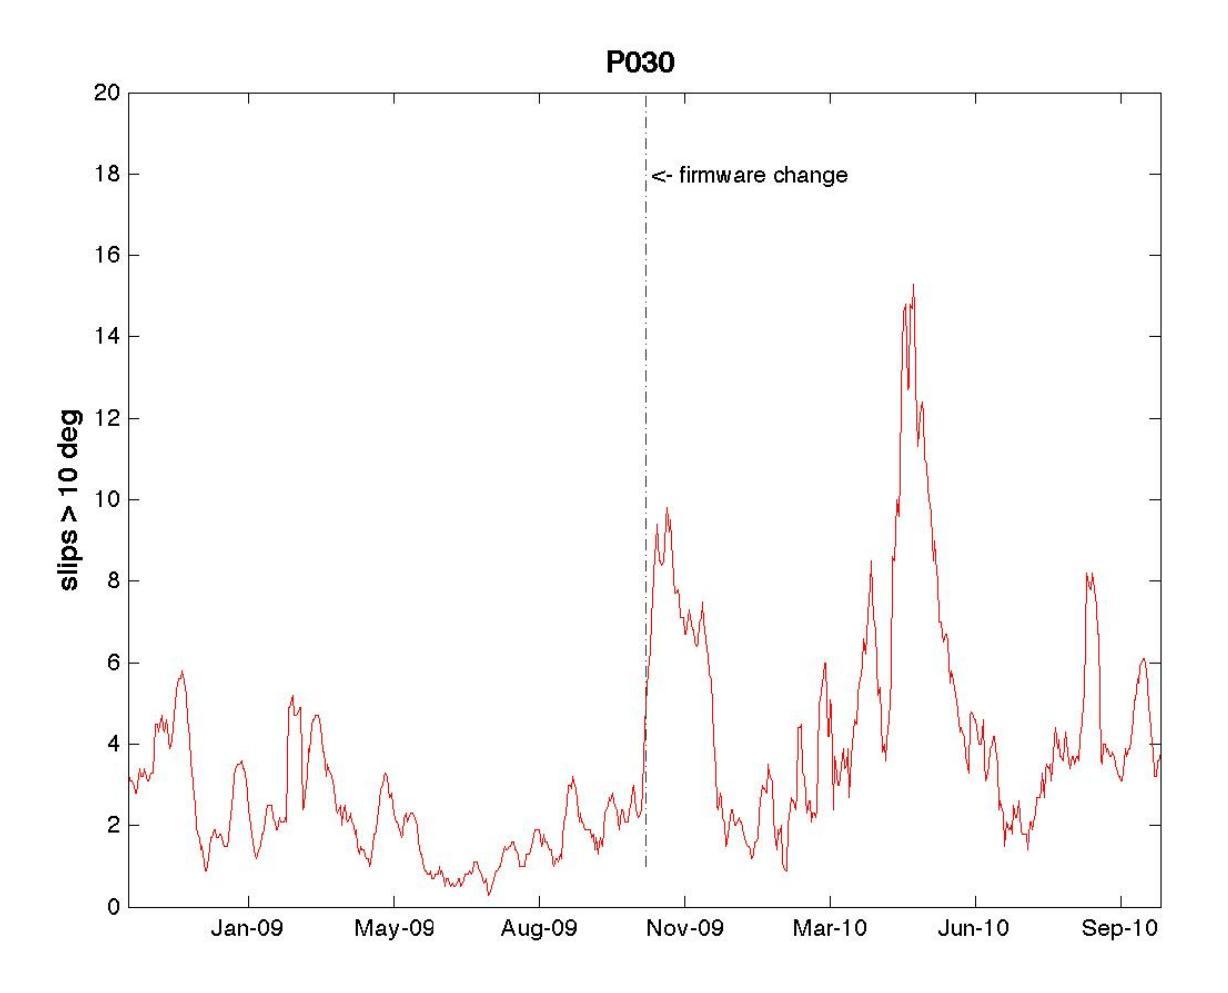
The following figure shows 24-hour totals of MP or IOD slips that occur at the site P030 when the elevation angles were > 10 degrees. The average number of IOD or MP slips before the firmware change is 2.34. The average IOD or MP slips after the firmware change is 4.90.

| degrees | | |
|---|---|---|
| Average IOD or MP slips > 10 degrees | Before fw change: 2.34 | After fw change: 4.90 |

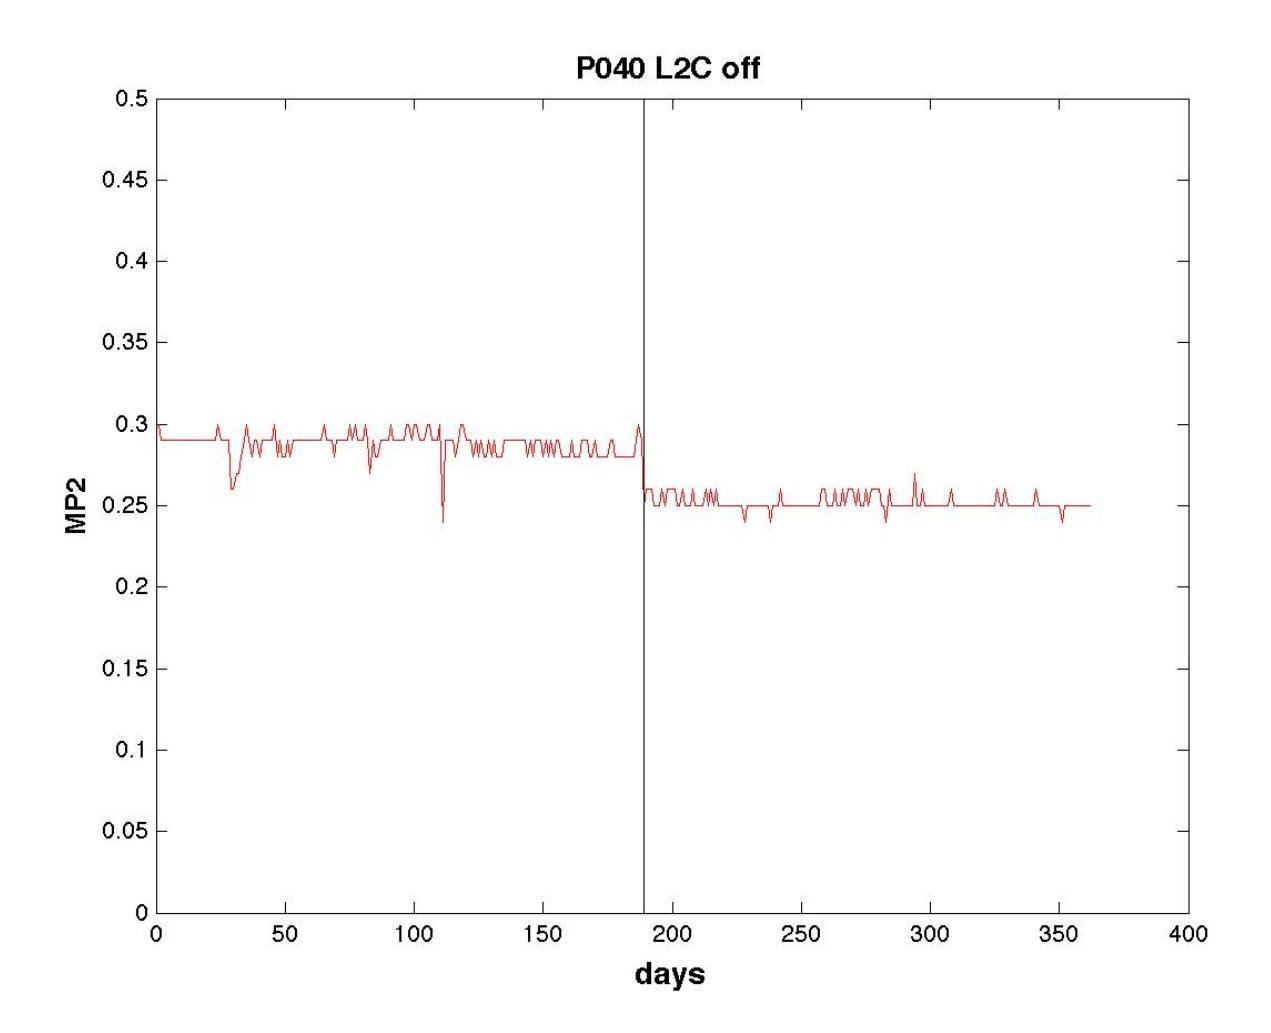
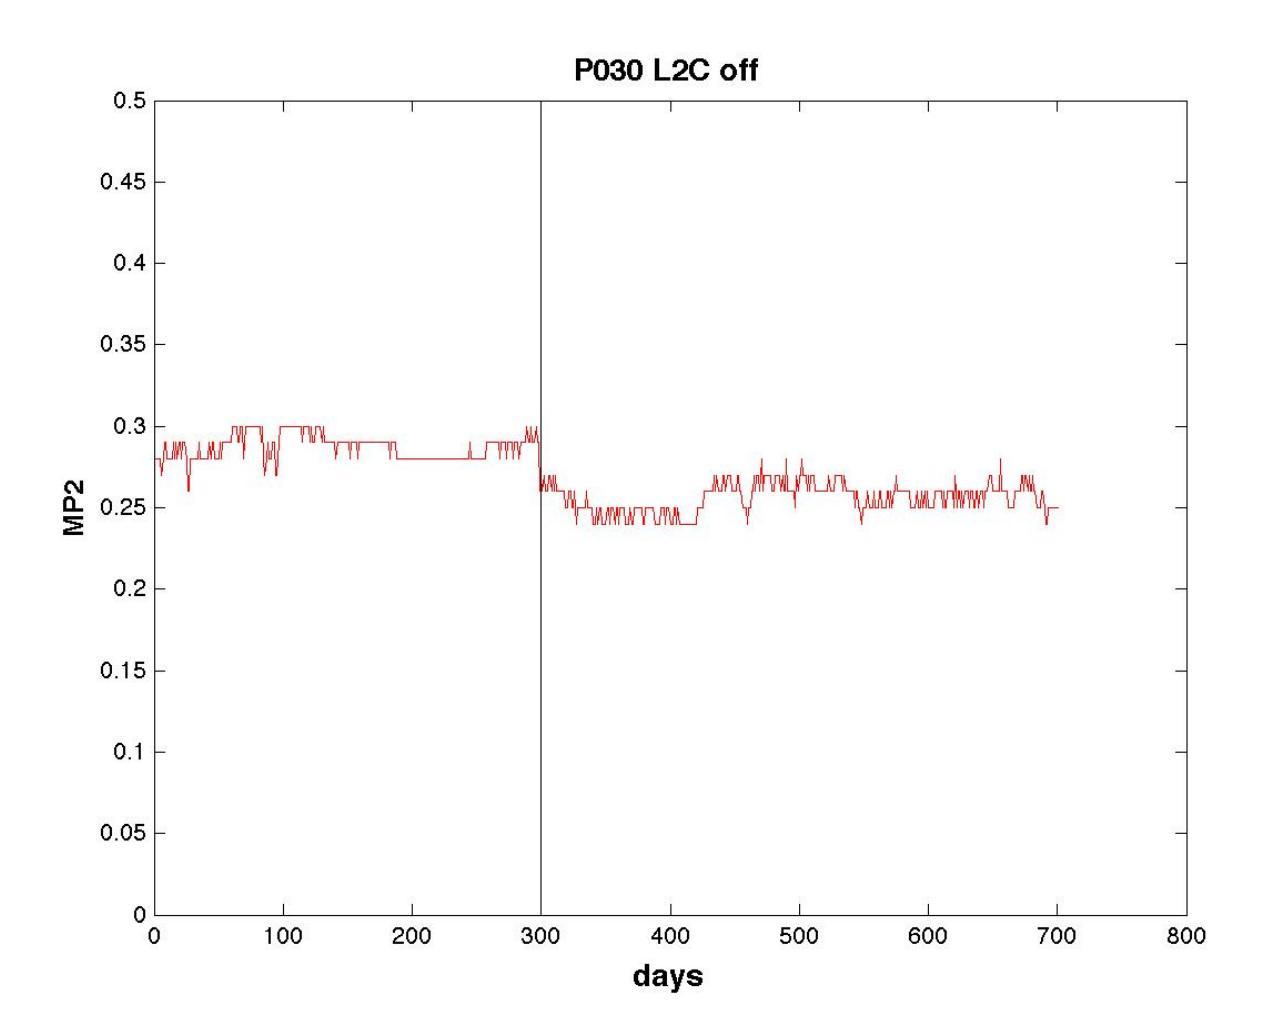
We also observed decreases in MP2 values after the firmware was updated at the sites P040 and P030. The figures below shows the MP2 values calculated by Teqc with respect to time.
