Trimble NetRS - tracking behavior changes after firmware upgrade

698 Henry Berglund March 10, 2011 GNSS Receiver Test Reports, Trimble NetRS 2700

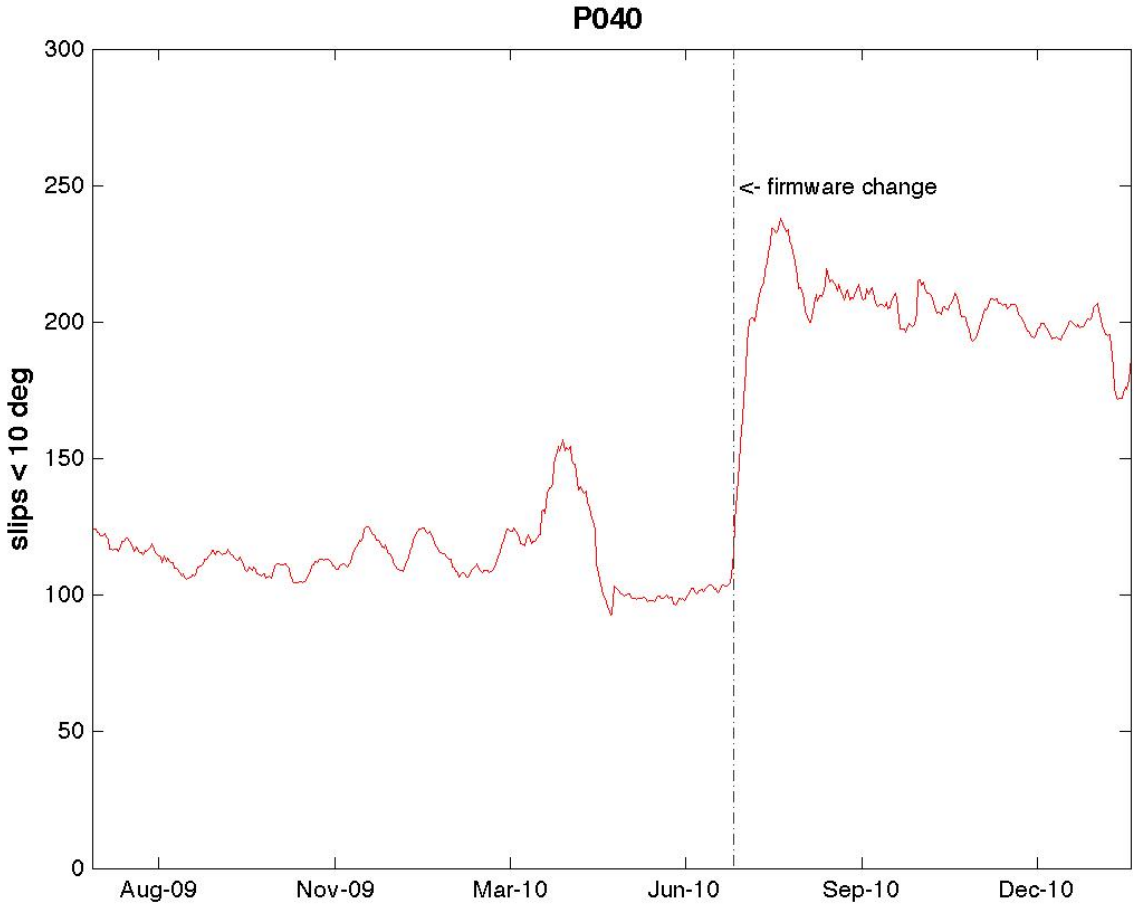
The following figure shows 24-hour totals of MP or IOD slips that occur at the site P040 when the elevation angles were < 10 degrees. The gray dashed line indicates when the receiver firmware at P040 was upgraded from 1.1-2 to 1.3-0. The average number of IOD or MP slips before the firmware change is 113. The average IOD or MP slips after the firmware change is 205.

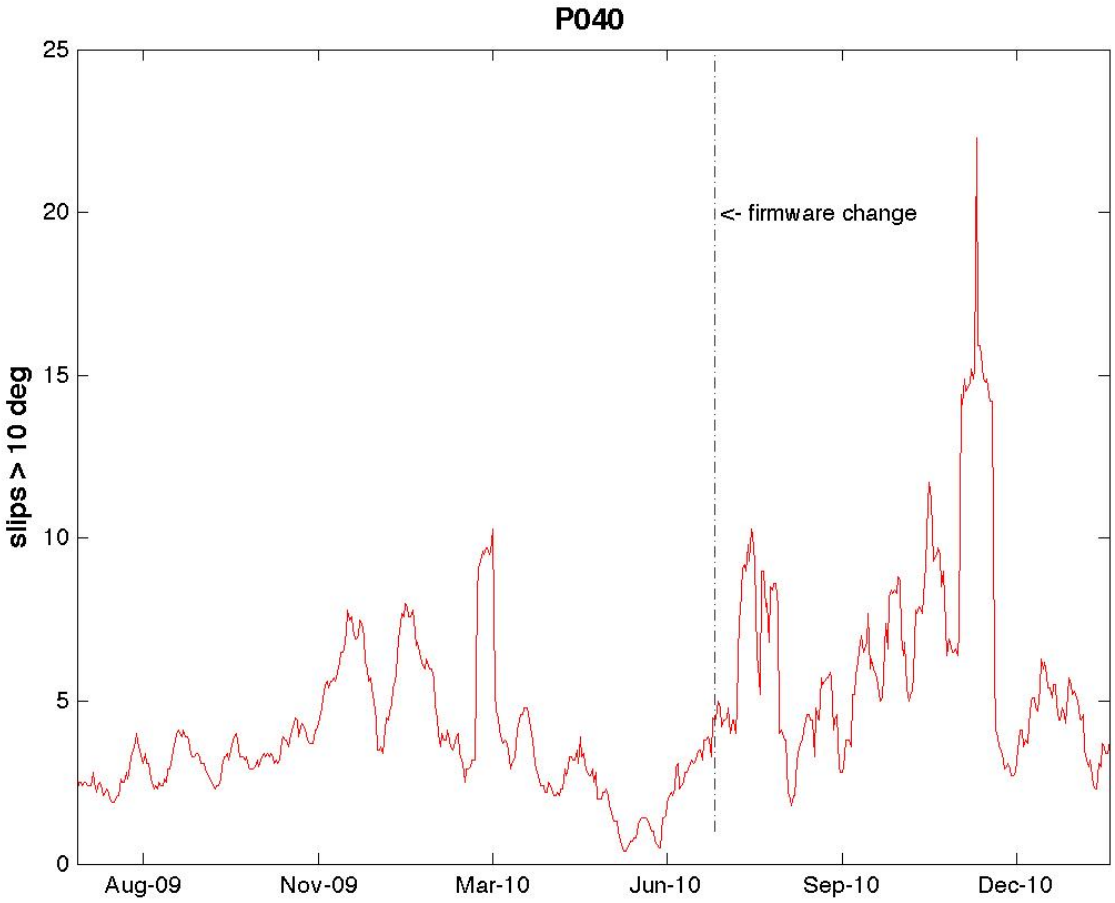
The following figure shows 24-hour totals of MP or IOD slips that occur at the site P040 when the

elevation angles were > 10 degrees. The average number of IOD or MP slips before the firmware change is 3.67. The average IOD or MP slips after the firmware change is 6.33.

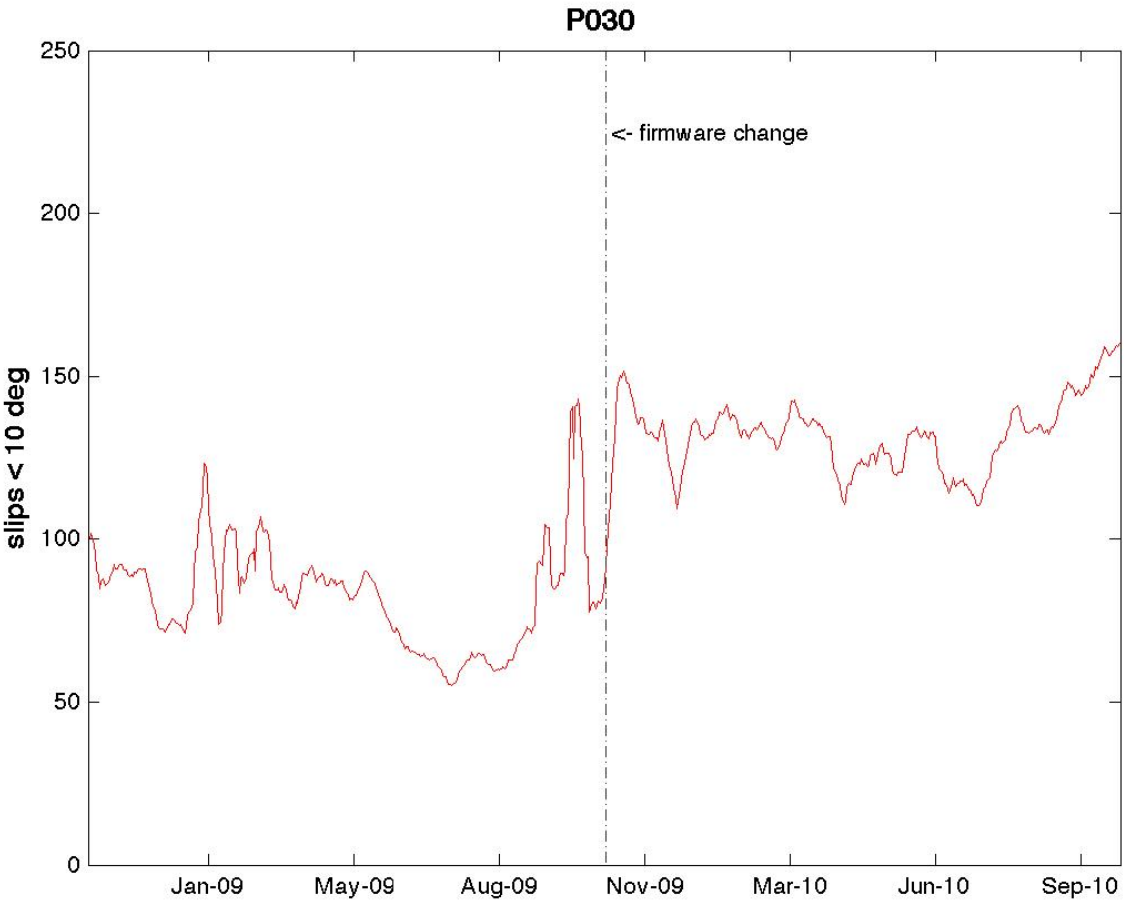
The following figure shows 24-hour totals of MP or IOD slips that occur at the site P030 when the elevation angles were < 10 degrees. The gray dashed line indicates when the receiver firmware at P030 was upgraded from 1.1-2 to 1.3-0. The average number of IOD or MP slips before the firmware change is 83. The average IOD or MP slips after the firmware change is 133.

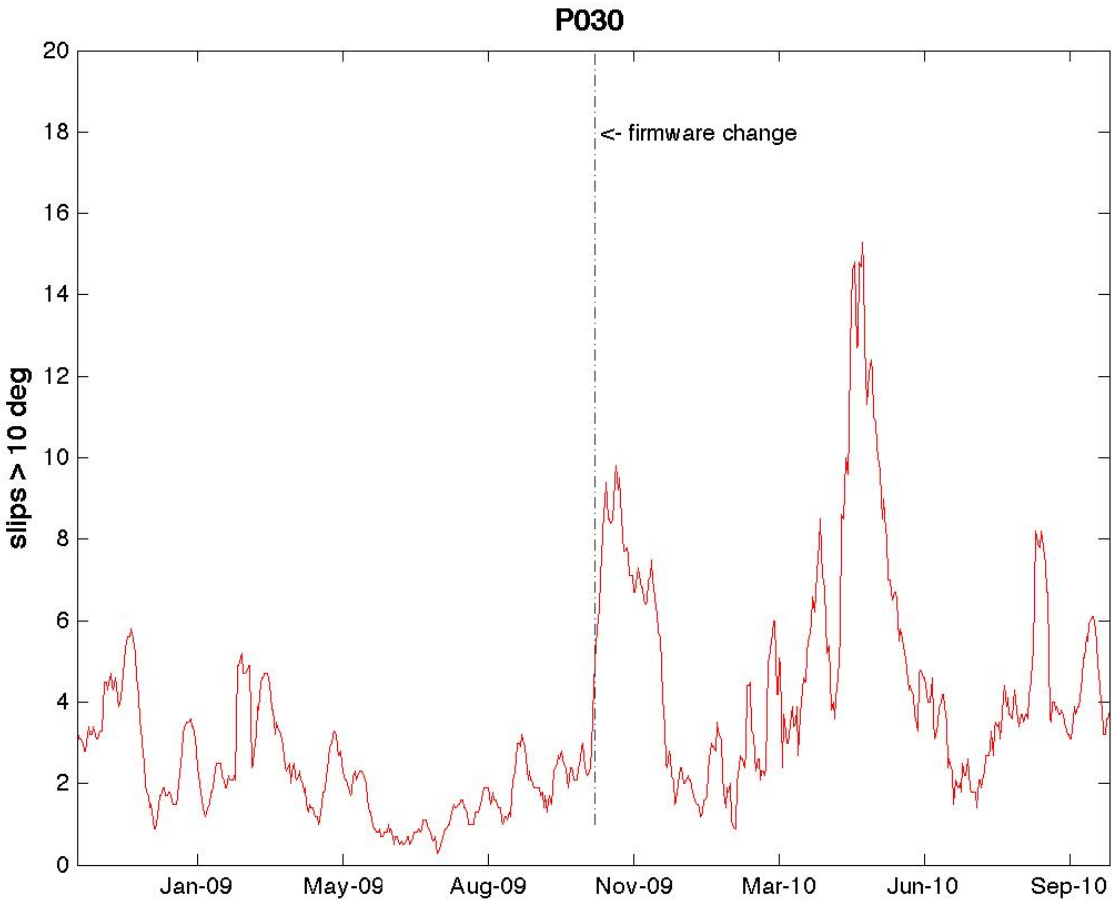
The following figure shows 24-hour totals of MP or IOD slips that occur at the site P030 when the elevation angles were > 10 degrees. The average number of IOD or MP slips before the firmware change is 2.34. The average IOD or MP slips after the firmware change is 4.90.

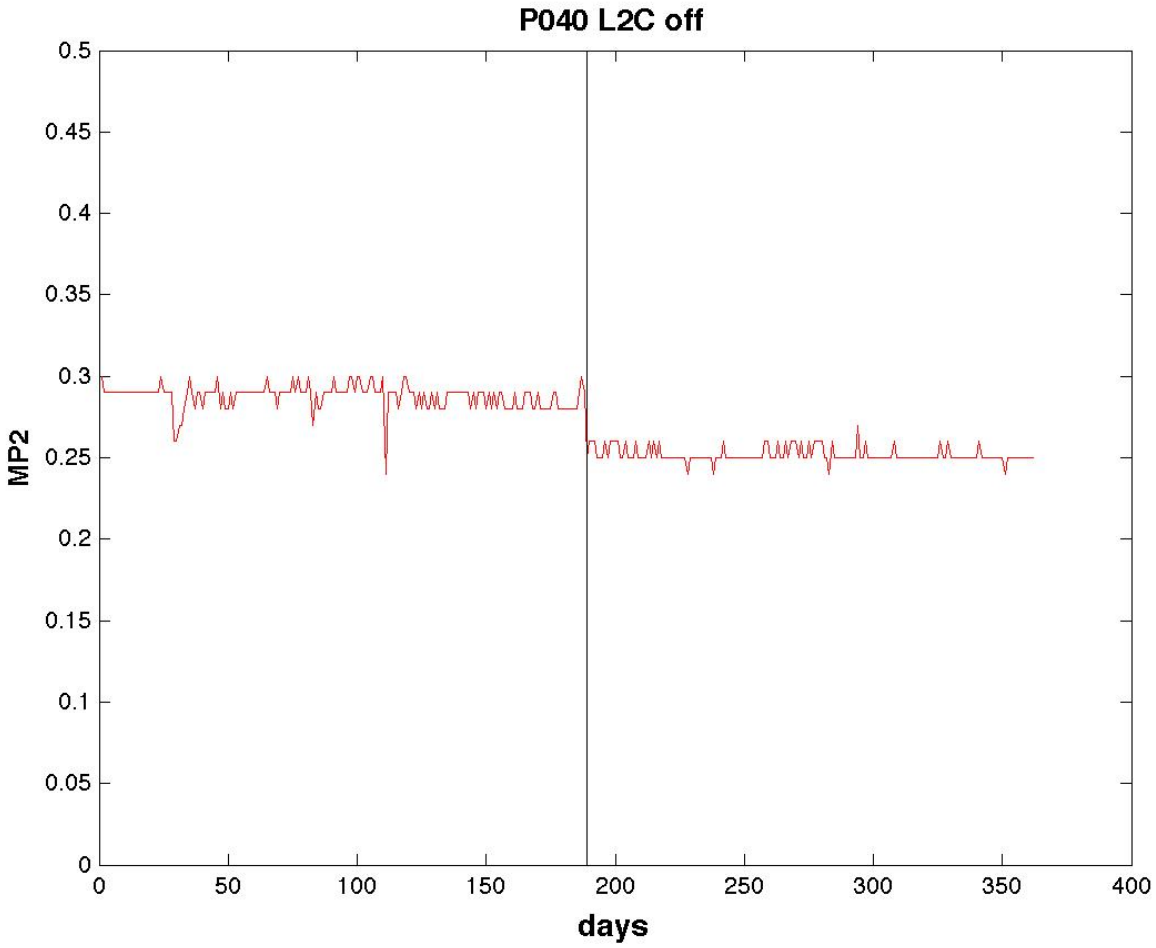
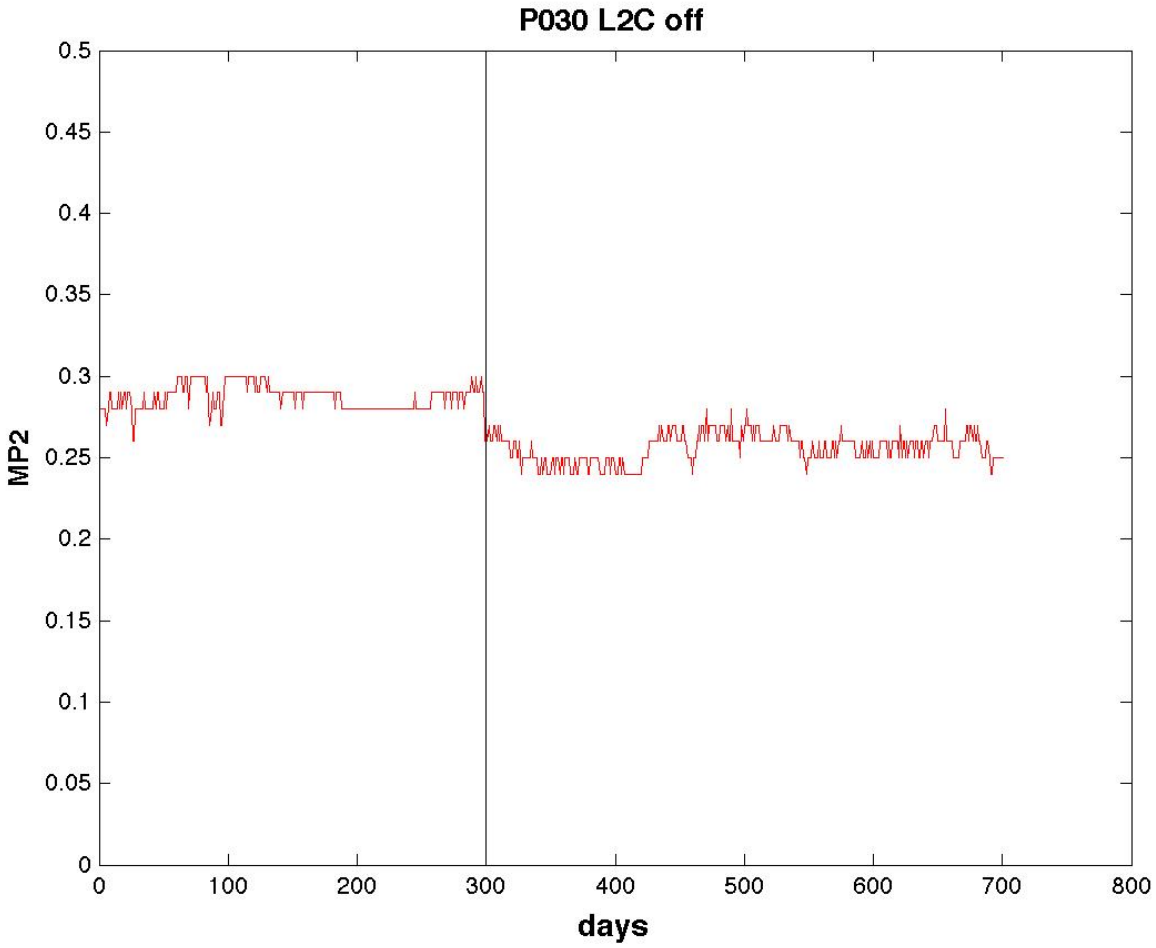
We also observed decreases in MP2 values after the firmware was updated at the sites P040 and P030. The figures below shows the MP2 values calculated by Teqc with respect to time.
