Iridium & GPS/GNSS Inteference from Iridium Data Transmitters

Update: GPS/GNSS Interference From Iridium Data Transmissions

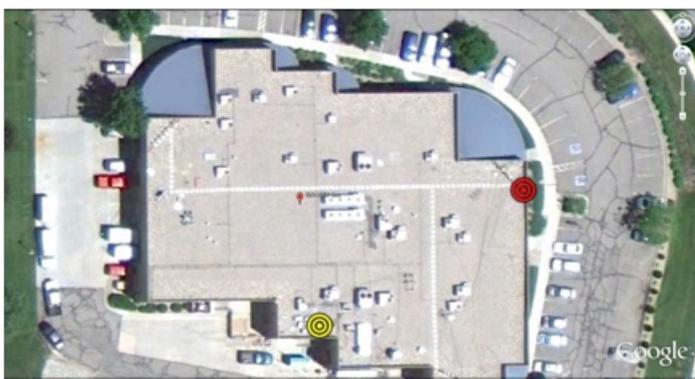
The observations used in this report were collected on the roof of the UNAVCO facility. The GNSS antenna test location is shown below with a red circle. The approximate location of the Iridium antenna bank is indicated with a yellow circle. The separation of the antennas is ~35 m.
